**Schwindt & Company**  
division of Artisan Style, Inc.  
7714 Carroll Avenue  
Takoma Park, Maryland 20912  
301 270-3554 [www.schwindtco.net](http://www.schwindtco.net)  
[rob@schwindtco.net](mailto:rob@schwindtco.net) email  
ASHI Certified, MD & VA Liscensed

Inspected By:  
**Robert Schwindt**

## **SAMPLE GARDEN STYLE CONDO REPORT #2**

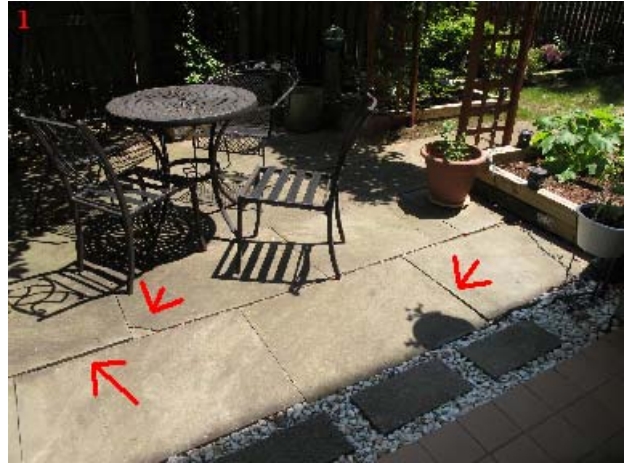
#### Patio - Flagstone

- Rear flagstone patio and walkway.
- There are open gaps inbetween some stones. These are a potential trip hazard. (safety) gaps should be filled with gravel dust or sand. Repairs needed.
  - A few flagstones are cracked or have corners broken off them. (cosmetic)

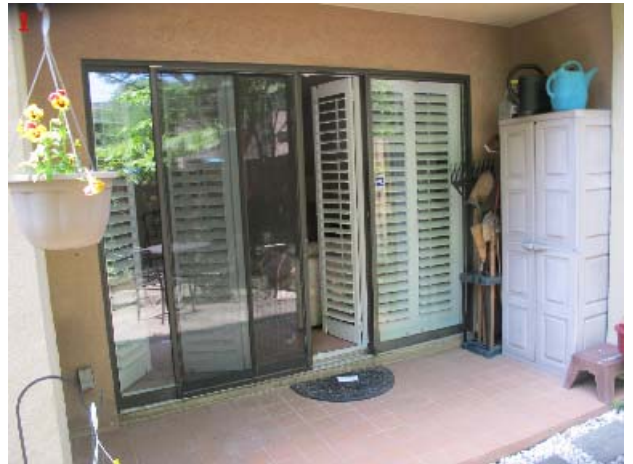
#### Porch/s - Inspected

Rear covered porch/patio area has concrete with tile floor. Area is covered by the building above.

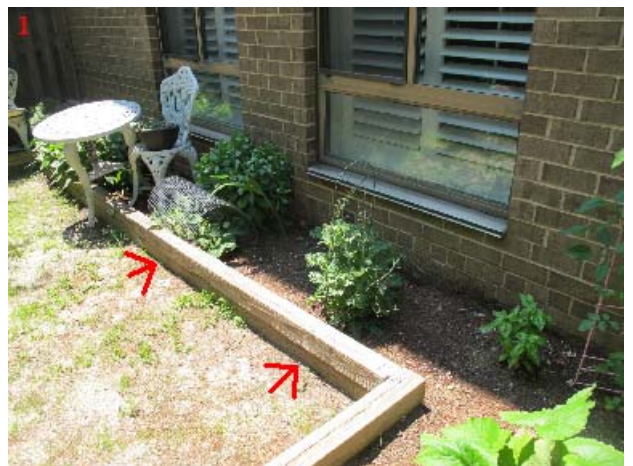
#### Grading - General Positive Grading

- Timber flower beds have been installed next to the house wall. Drain holes should be added to prevent water from standing next to the house wall. Water standing next to the wall could cause seepage to the inside. Repairs needed.

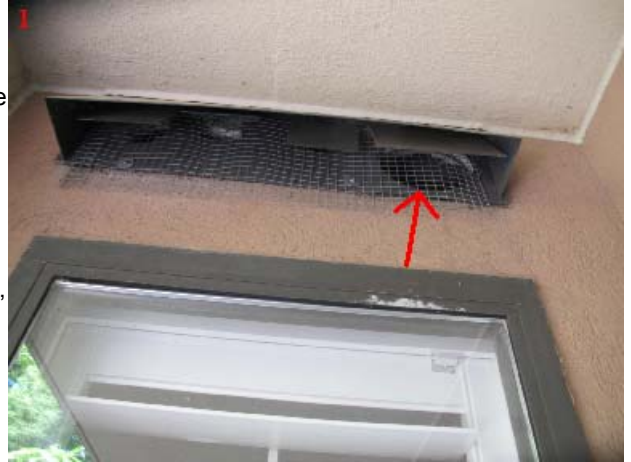
Outside Vent Cap/s - Dryer, Bathroom/s, Kitchen Exhaust

1. Screening has been installed to keep birds from nesting. The screening is holding open all the vent wind caps. Cold air can enter back through the vents. Repairs needed. The screen should be removed. If a screen is installed it should be on the under side of the vent cap. This would permit the wind flaps to function. (See Picture #1)

2. The microwave exhaust has very marginal flow when checked outside. Not typical. Not known if the exhaust pipe is separated above sheet rock in living space or maybe the microwave fan was not properly installed. Further investigation needed. (See Picture #1, red arrow)

Inspection and repairs are needed by a licensed Contractor.

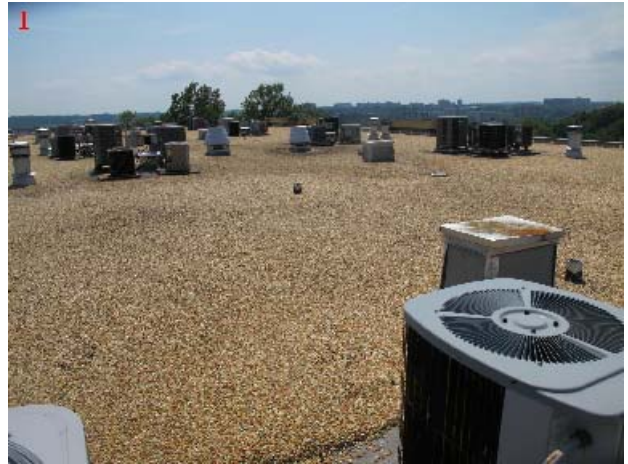
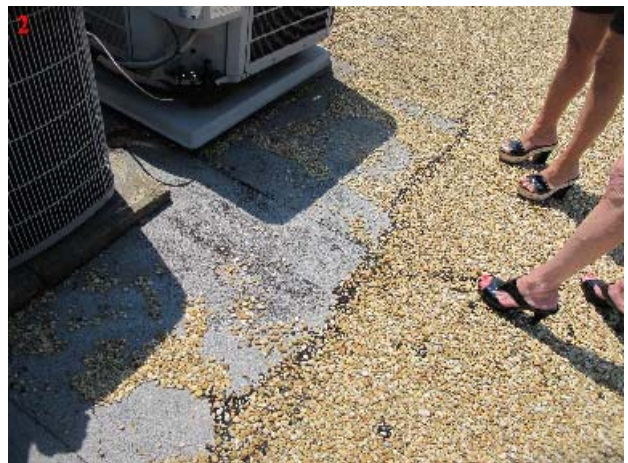
#### Roof - Roof Comment

Roof Comment:  
Cursory view of the roof when the inspector was on the roof to look at the condenser unit.  
Roof is a single ply modified bitumen base. With tar and gravel installed on top. Roof is not at end of life.

Further investigation is needed to find out when the building roof was last replaced and what plan or reserves have they set aside for future replacement.

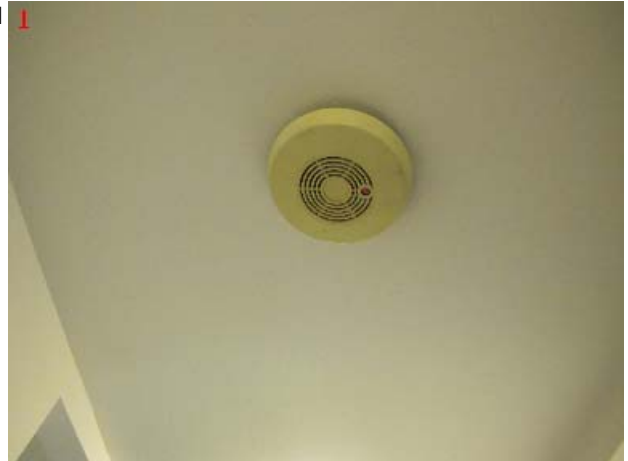
#### Smoke Detectors - Present on every level.

Existing smoke detector/s are aged. These units should be replaced every 10 years. Suggest installing new unit/s with 10 year battery or battery back up. (suggested safety improvement)

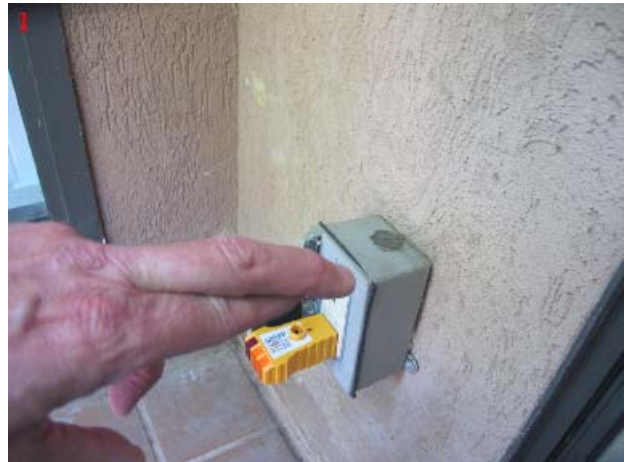
#### GFCI Outlets - Bathroom/s, Outside, Kitchen

1. The rear outside GFCI breaker is not breaking when tested. Repairs needed. (safety) (See Picture #1)

GFCI house outlets need to be inspected and repaired as needed for safe and normal function by a licensed Electrician.

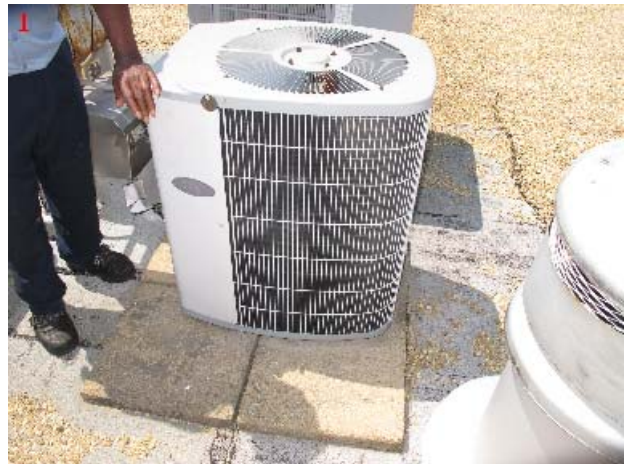
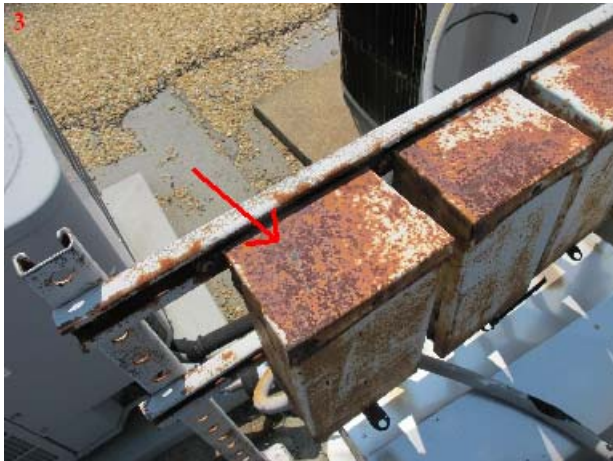
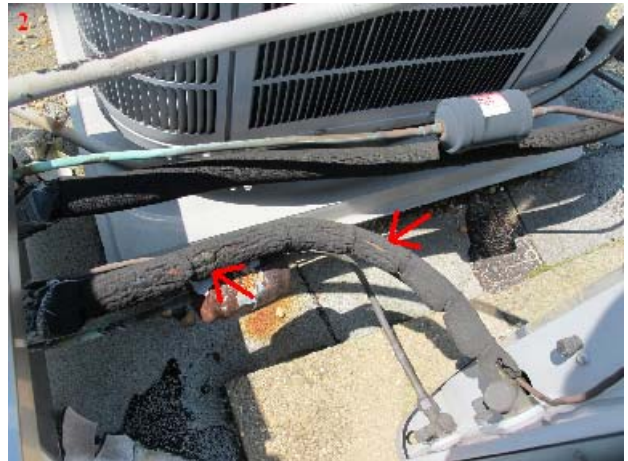
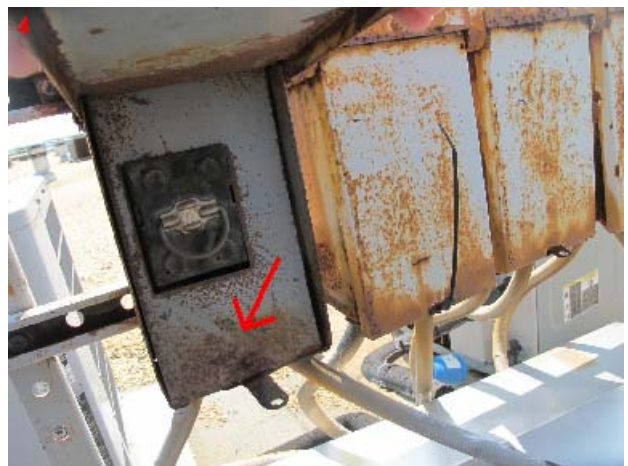
#### #1 (HP) Condensor/ Compressor - Roof Unit

Roof heat pump condensing unit. (See Picture #1)  
a. Coolant line insulation is damaged and needs to be replaced. Loss of unit efficiency. Repairs needed. (See Picture #2)  
b. Outside unit electrical disconnect box and exterior and interior rust damage. (safety) Needs to be replaced. Water has been entering the box. (See Picture #3,4)  
Repairs/Service needed by licensed HVAC contractor.

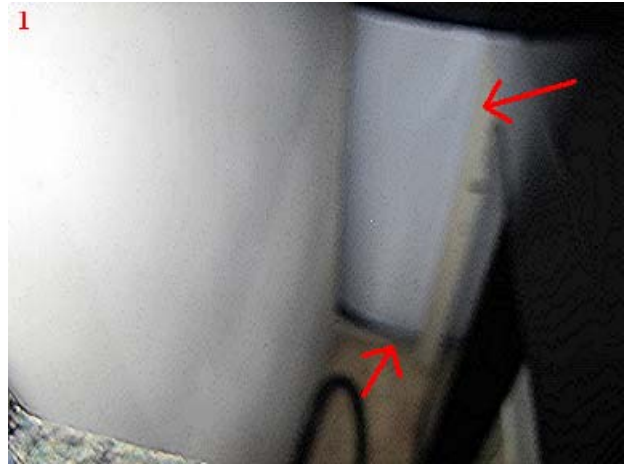
#### #1 Water Heater Type - Electric

The water heater is located under the kitchen counter. The range/oven would have to be removed. Moving appliances is not within the scope of a home inspection. The inspector lifted the front of the range oven and pulled in forward about 10 inches. This inspector did not want to damage the floor. The flooring was not damaged. The inspector had a limited view of the electric water heater. There is a safety leak pan under the unit. NO water was seen in the pan. Not known if the pan is connected to a drain. Good idea to installed a battery powered leak alarm into the pan to warn if the unit starts leaking.

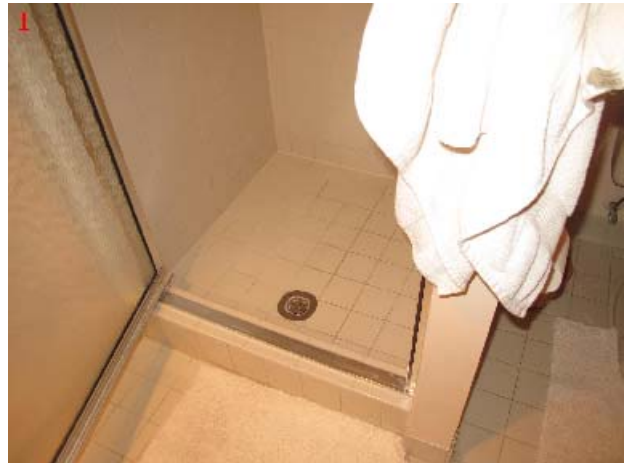
#1 Bathroom Shower Pan - Custom Tile

Custom shower pans. The actual shower pan cannot be viewed. The pan in older buildings was lead metal. (not a safety concern) Newer home have vinyl pans. One the pan is installed it is covered with tile or marble. The inspector checks around the pan and below the pan if its on an upper level for signs of leaking. Old lead pans can age and fail. No leaking viewed.

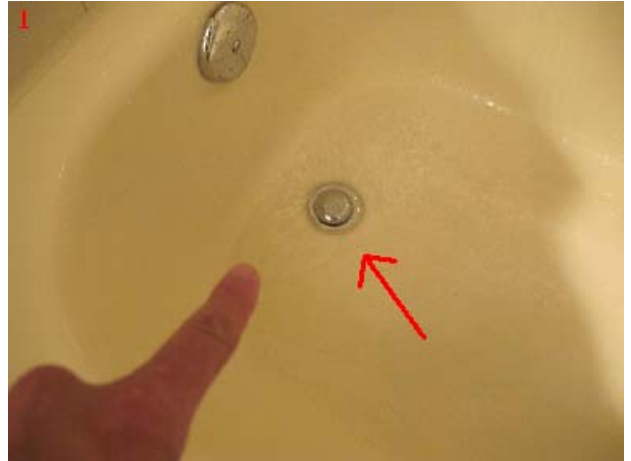
#2 Bathroom Traps/Drains - PVC

Pop up tub stopper is not properly operating. Repairs needed.

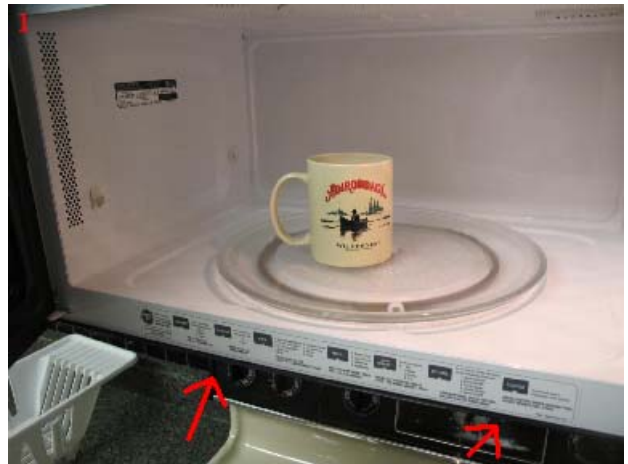
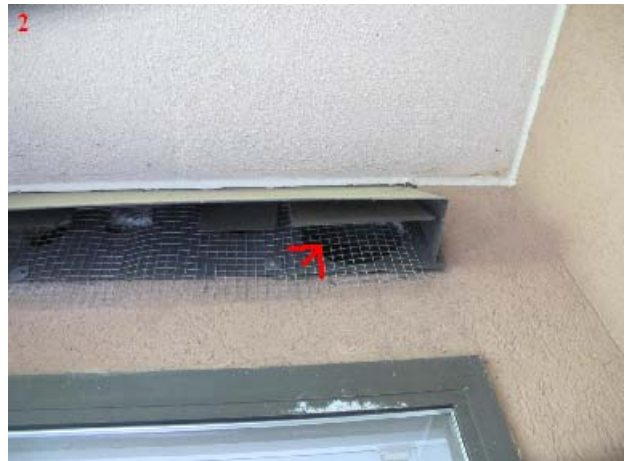
### Ventilator - Microwave Exhaust

Very low air flow outside when the over range microwave exhaust was operated. Further investigation needed.

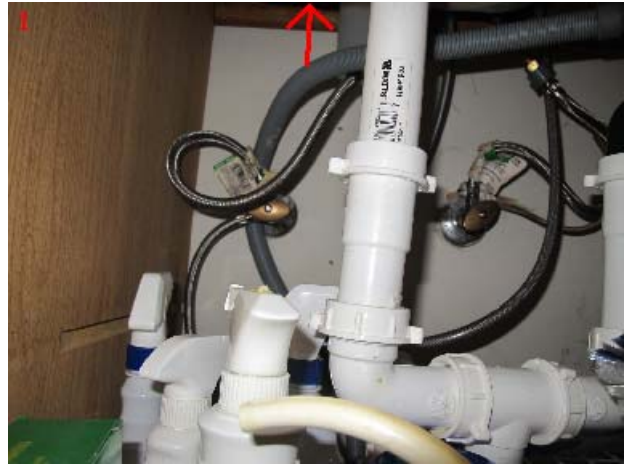
Dishwasher - Operating

1. No air gap installed, the drain hose from the dishwasher needs to be looped up in the sink base cabinet as close to the counter top as possible and secured there. (Health/Safety) This is needed to prevent dirty water from the disposal from entering the dishwasher. (See Picture #1) Repairs needed.

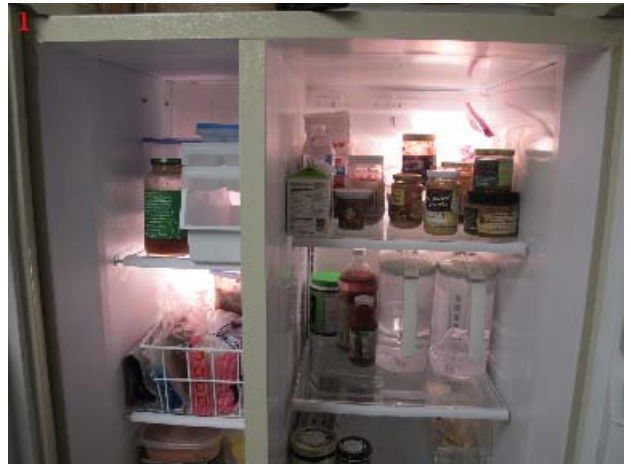
Kitchen Refrigerator - Operating

Aged Refrigerator, Typical life 15-25 years.

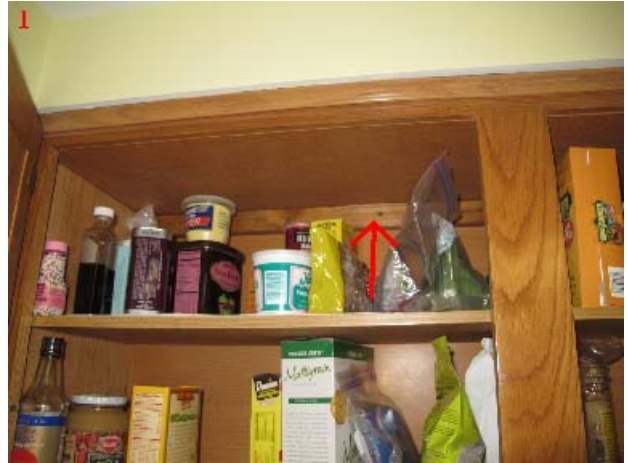
#### Kitchen Cabinets - Upper, Lower

1. Upper cabinets are connected to the wall using hardened sheet rock type screws. This is not proper because hardened screws are brittle. The heads could break off and the cabinet could fall. (safety) Softer, large headed screws are provided with most new cabinets and or available at hardware stores. Proper cabinet hanging screws need to be installed next to or below existing screws. Repairs needed.

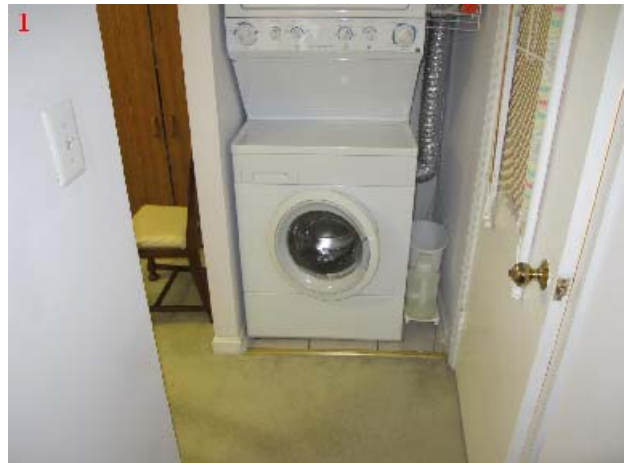
#### Clothes Washer - Operating

Clothes washers are operated in a single mode only. cursory inspection only. Unit is checked to see that it fills, operates and drains. Tested in only one washing mode. Clothes washer is aged unit. Typical life 7-12 years.

No safety leak pan was observed. A failed washer could cause damage to unit flooring and possible unit ceilings below. Not known if there is a drain in the floor under the unit, due to no way to view.
