Schwindt & Company
division of Artisan Style, Inc.
7714 Carroll Avenue
Takoma Park, Maryland 20912
301 270-3554 www.schwindtco.net
rob@schwindtco.net email
ASHI Certified, MD & VA Liscensed

SAMPLE GARDEN STYLE CONDO REPORT #3

COVERPAGE

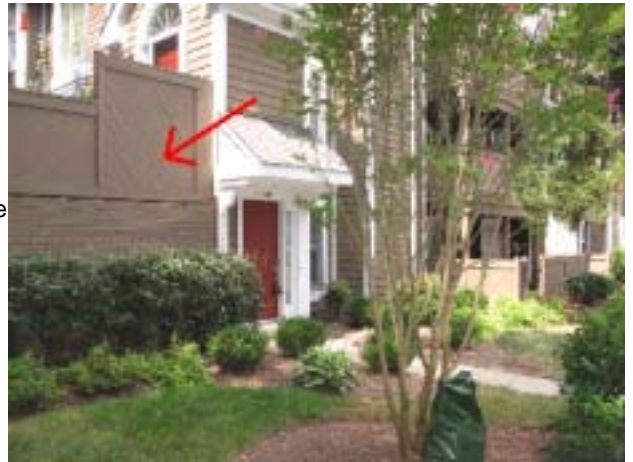
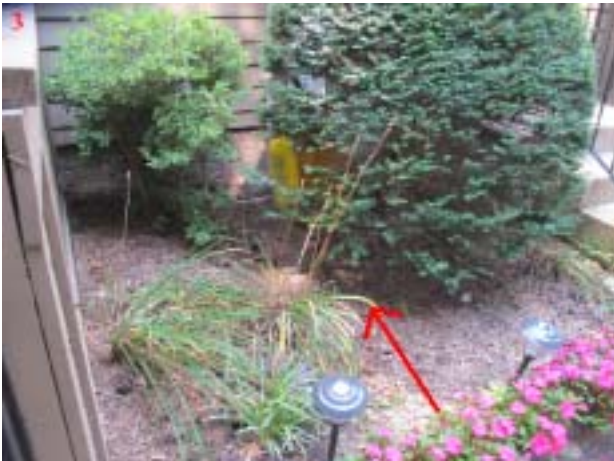
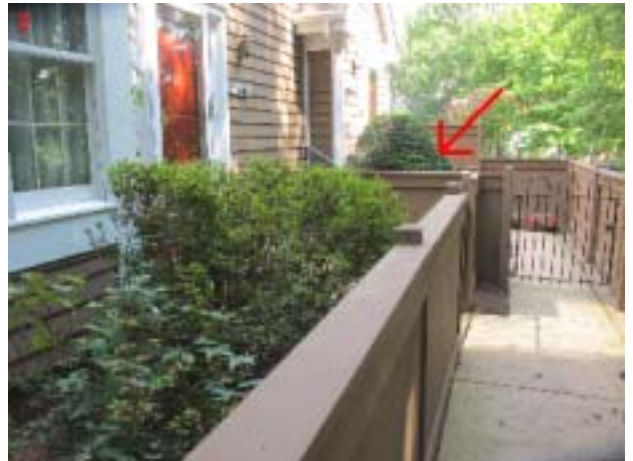
Grading - Flat Grade Next to Building

Flat Grade Next to Building at: Left side of the building. Rain water can stand here.

Water standing next to the house can increase risk of water entry and can over time cause damage to foundation.

The left side of the living/dining rooms are below grade. The left side of the building is pictured below. Good idea to work with the condo to see if the grading could be improved here. No seepage was seen inside the unit.

Fill dirt needs to be added next to the building to create a positive slope away structure.

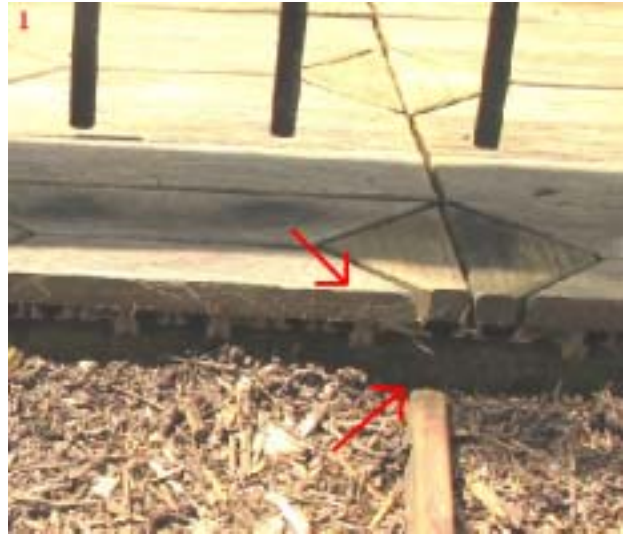
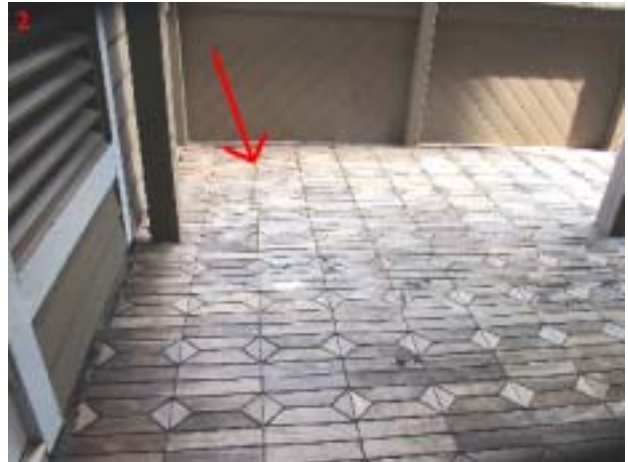
Patio - Brick

Original patio was brick pavers. A wood surface material has been installed on top of the brick patio. (See Picture #1)
Some areas of the brick patio has settled. No damage seen on the wood surface material. Should the area continue to sink, some repairs to the brick patio below could be needed in the future.

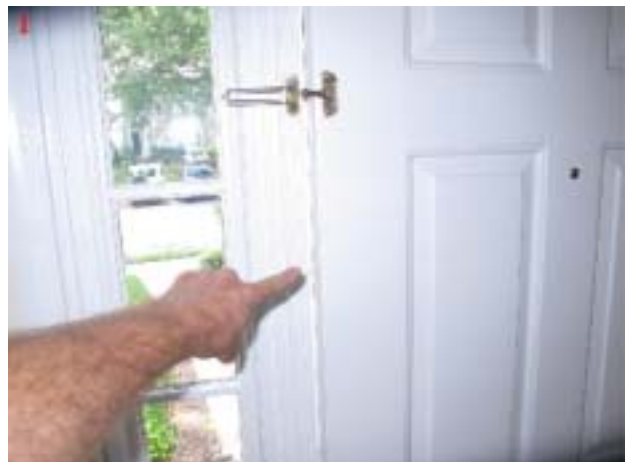
Unit Entry Door/s - Operated

Front entry door, operated.
a. The door sticks on the jamb. Adjustments are needed. (See Picture #1)

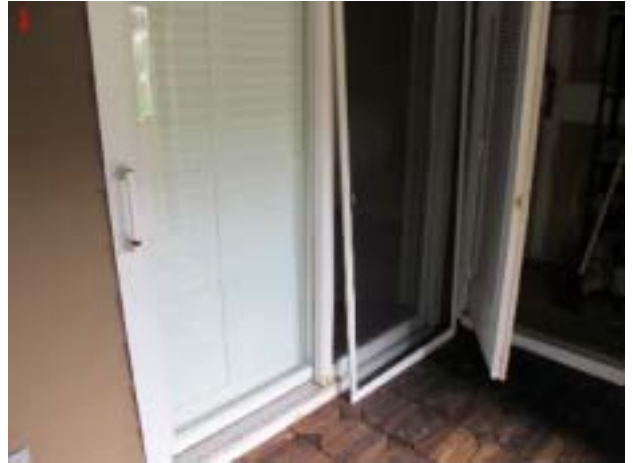
Unit Entry Door/s #2 - Not all operated

a. The screen door has fallen out of track. Repairs needed. (See Picture #1)

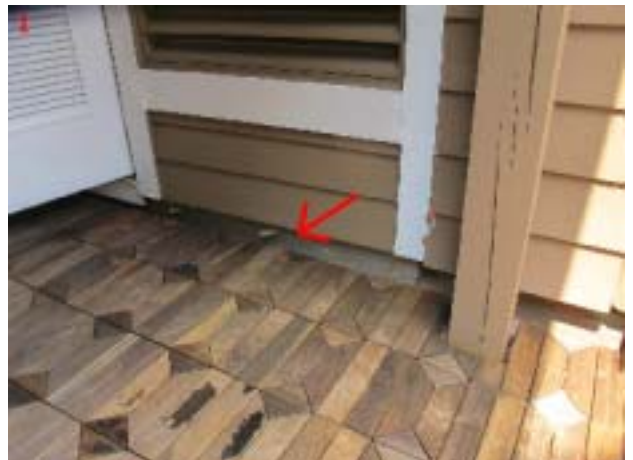
Small view of foundation wall. Paint is peeling and flaking. Paint not required on the structure. Scrape and paint is needed.

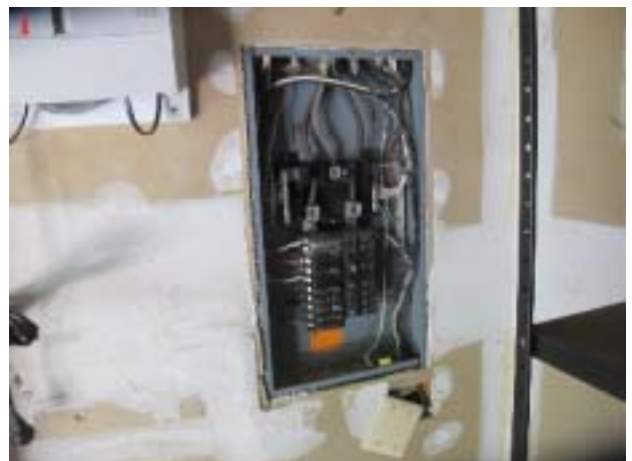
#1 Panel Type - Breakers

When the hall bathroom electric ceiling heat was operated. The breaker tripped. Further investigation and repairs needed.

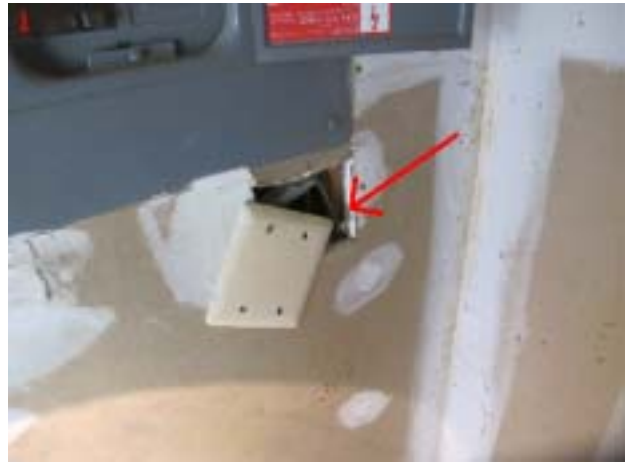
House Branch Wiring/Circuits - Plastic Jacketed (ROMEX), View Limited, Copper Wires

Loose and open junction box on wall below the main panel. (safety)
Repairs needed. (See Picture #1)

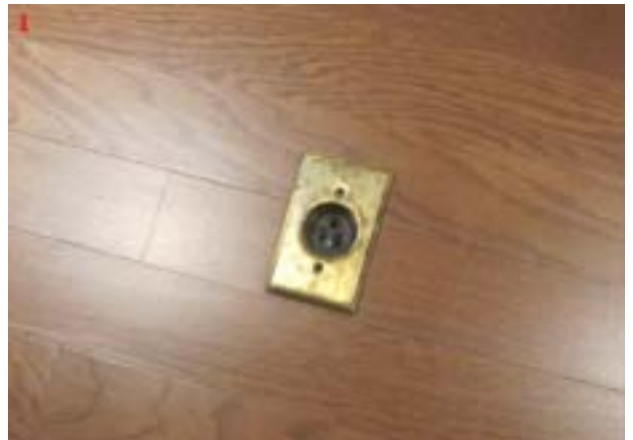
Interior Outlets - Inspected

Outlet on living room floor needs screw in plug installed to keep dirt from entering into the socket. (safety) Repairs needed.

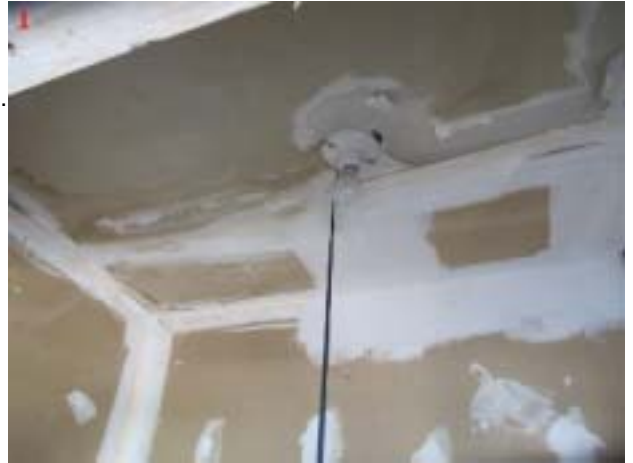
Lights/Ceiling Fans/Switches - Inspected

Patio storage room pull chain light is not operating. The chain is stuck. Repairs needed.

Master bathroom fan light. One bulb not operating. Repairs needed.

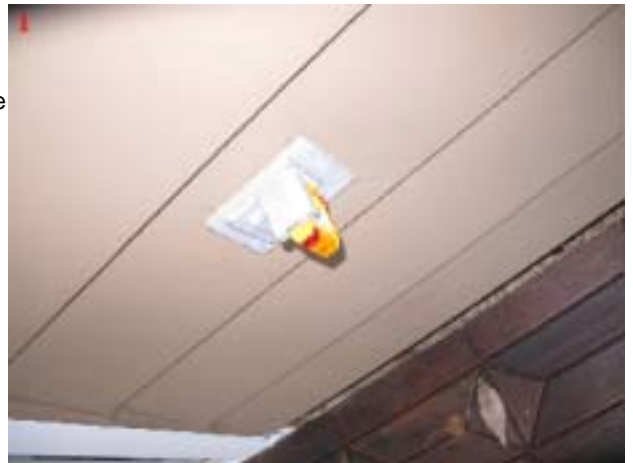
The patio area outlet is not GFCI protected as required. (safety)
Repairs needed. (See Picture #1)

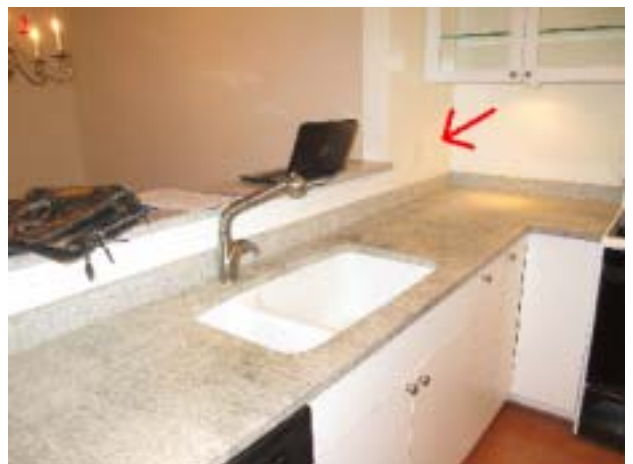
The kitchen has been renovated and the outlets within six feet of the kitchen sink have not had GFCI protection added. (safety) Repairs needed. (See Picture #2)

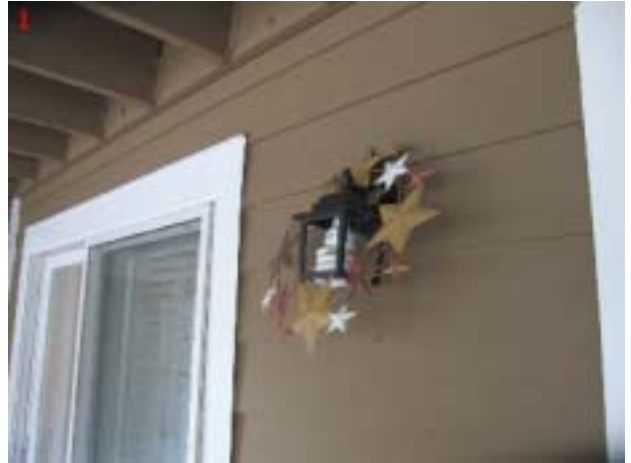
Outside Electrical - Inspected

Patio outside door light is not operating and glass lenses are missing in the fixture. (safety) Repairs needed.

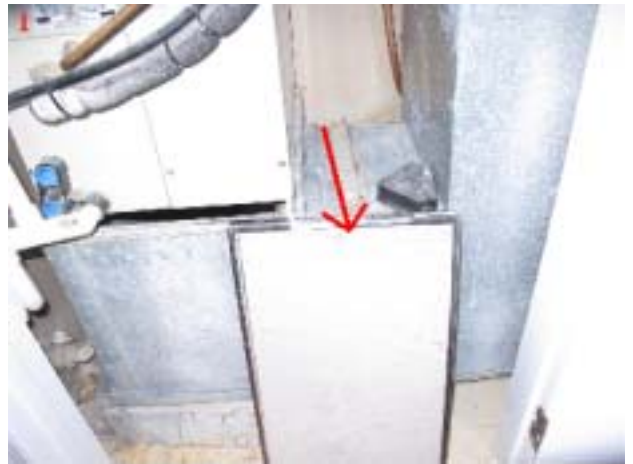
#1 (HP) Filter - Washable Filter, Electrostatic Filter

Filter is very dirty, showing lack of Maintenance. Service needed.
No filter slot cover installed. Dirty air can enter the system. Repairs needed. Present but not installed.

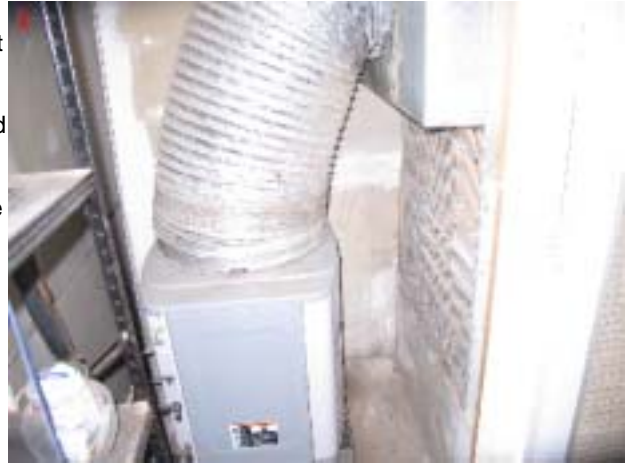
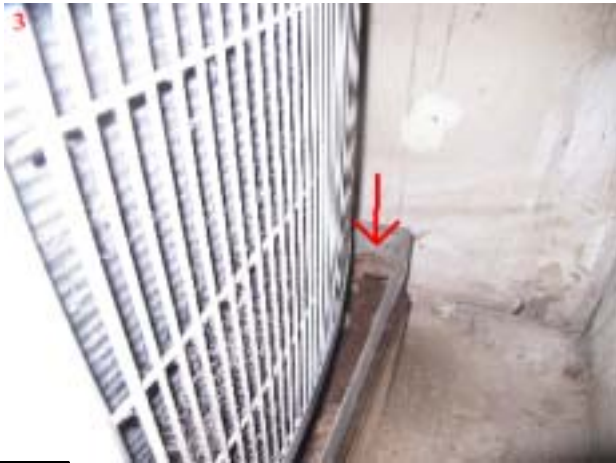
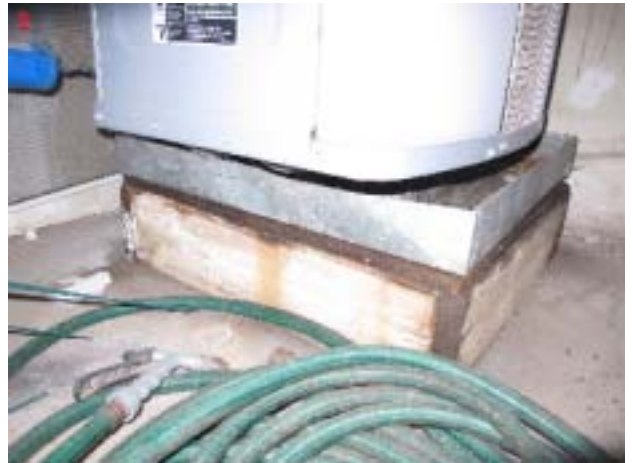
#1 (HP) Condensor/ Compressor - Other

Unit is installed in patio closet area. This is not typical, but suspect it is proper. (See Picture #1)

- a. The condensation pan below the condenser has rust damage and has leaked to wood stand below. The pan needs to be replaced. The wood pan should be inspected and repaired as needed.
- b. The condenser unit is rattling loudly. The condenser should not be supported by the pan, legs or supports need to be added under the unit.

Repairs/Service needed by licensed HVAC contractor.

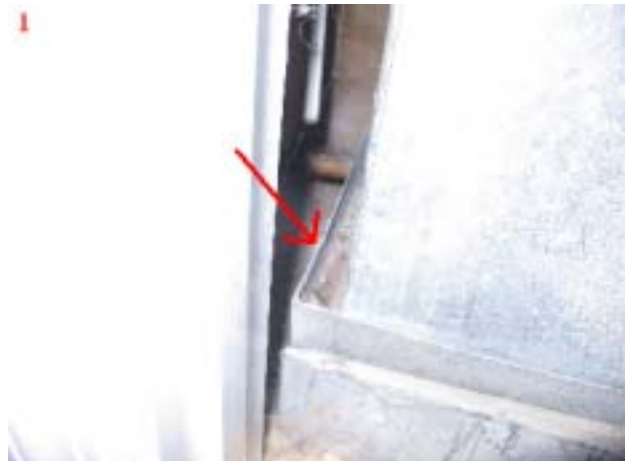
#1 (HP) Air Handler - Inside Unit

Cooling coils in the air handler are dirty and need to be cleaned for the system to have normal function.

The emergency leak pan under the air handler has much dirt and debris in it. Needs to be cleaned. (See Picture #1)

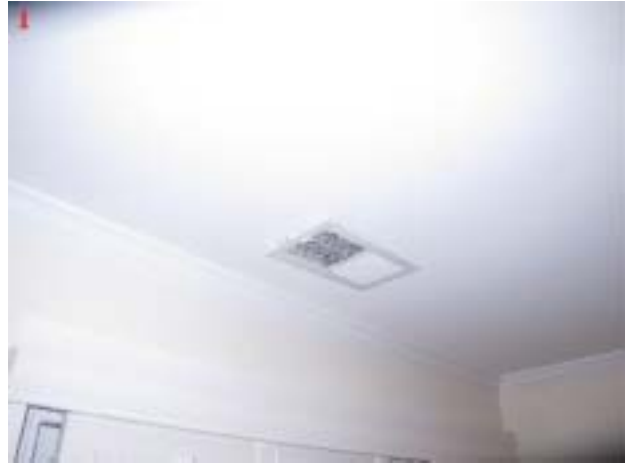
#1(HP) Distribution Heat/Cool - Ductwork, System Registers

Ceiling register/s is loose to the ceiling. Repairs needed.
a. Master bedroom (See Picture #1)

Middle bedroom single ceiling register has marginal air flow. This could effect heating and cooling on extreme temperature days. Further evaluation and repairs needed.

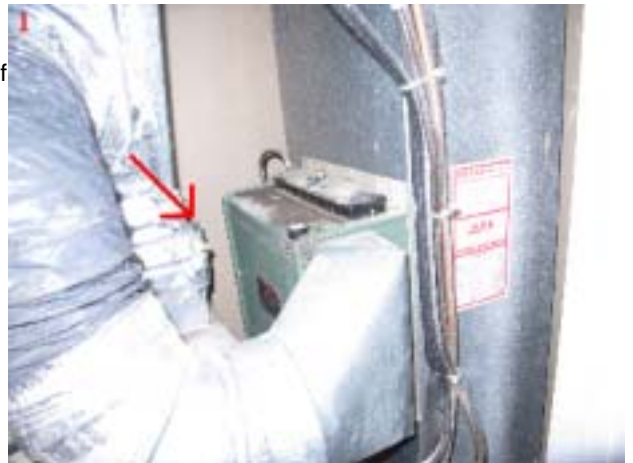
#1 (HP) Humidifier - Evaporator

Full Humidifier evaluation is not in scope of the inspection. Unit was not turned on at the time of the inspection. Humidifiers need to be serviced every year to prevent the build up of scum or mold in the unit. There is no sign that this unit has been recently serviced. The humidifier should be cleaned and inspected by a Licensed HVAC contractor to assure safe and normal function.

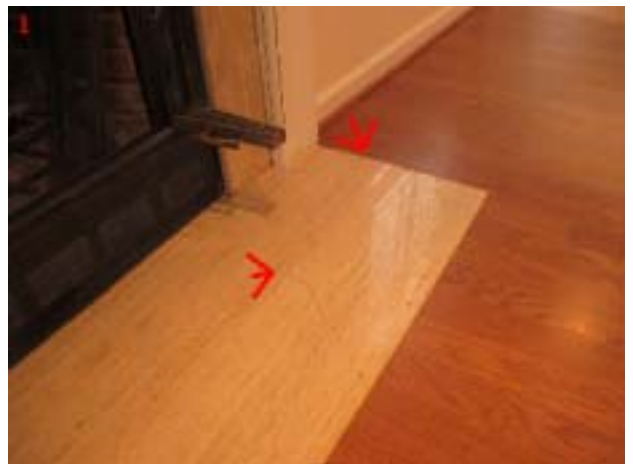
#1 (FP) Hearth - Flush Mounted

Marble hearth is cracked and settled at right side. Repairs needed.

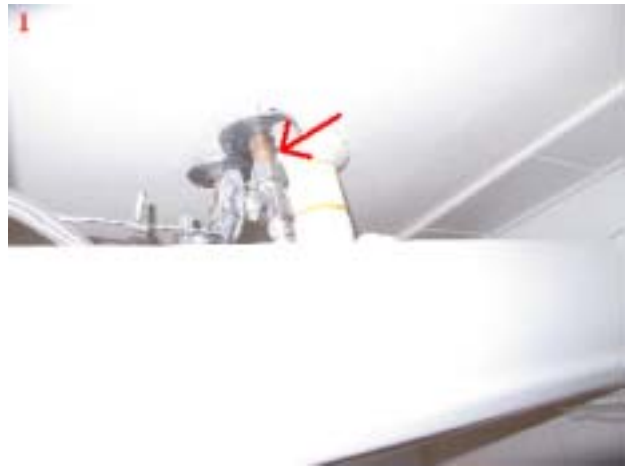
Water pipe viewed at sink areas were made of copper. (See Picture #1)

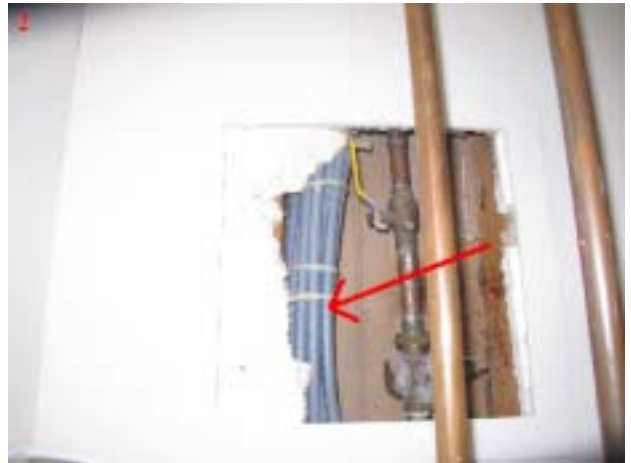
When the main water shut off valve cover was removed a bundle of Polybutylene water pipes was seen. (See Picture #2)

Polybutylene piping systems are no longer installed due to a higher rate of failures versus other types of pipe. Often these water pipe systems end up needing to be replaced. This can be costly and could require a special assessment. Further investigation needed. Consult with the Condo Association for more info.

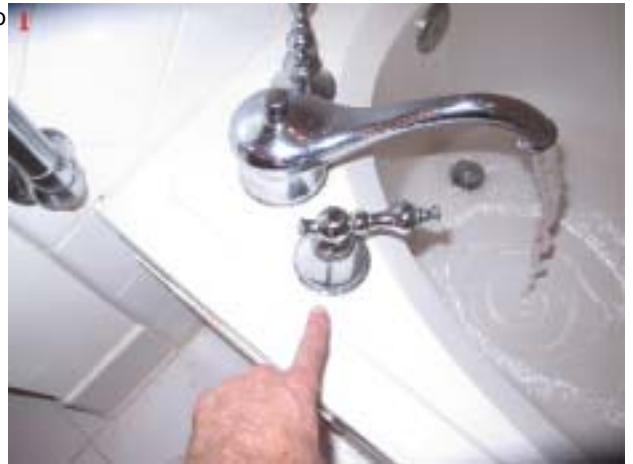
#1 Bathroom Faucets - Sink/Tub/Shower

Left tub faucet is loose to the tub surface. Repairs needed. Needs to be secured

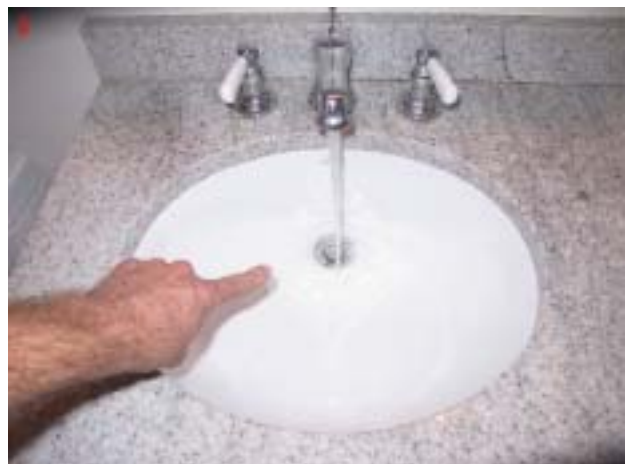
#1 Bathroom Traps/Drains - PVC

Sink drain pop up is not operating. Repairs needed.

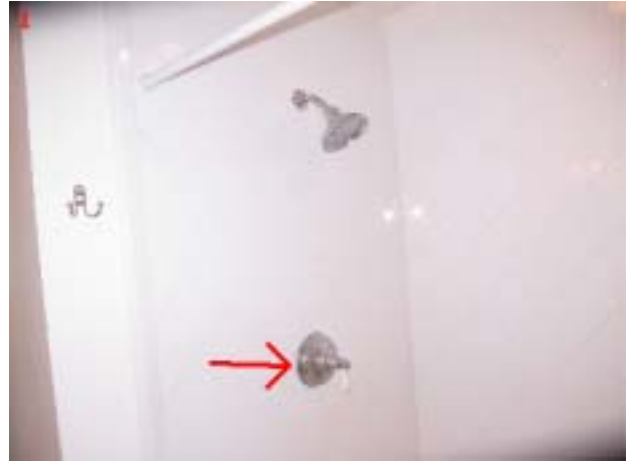
#1 Bathroom Tub Surround - Tile

Shower mixer escutcheon trim needs to be caulked to the wall, to keep water from entering behind the wall.

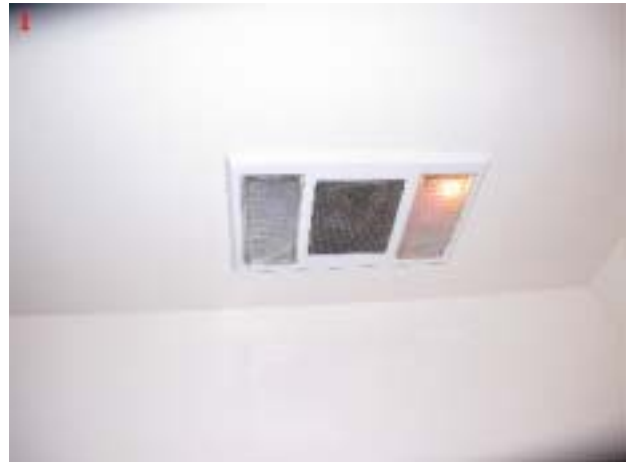
#1 Bathroom Ventilation - Exhaust Fan, Supplemental Heat

Fan and Supplemental heating unit are combined. Tripped the circuit breaker when the heat was operated. Repairs needed. One light bulb in this fixture is not operating.

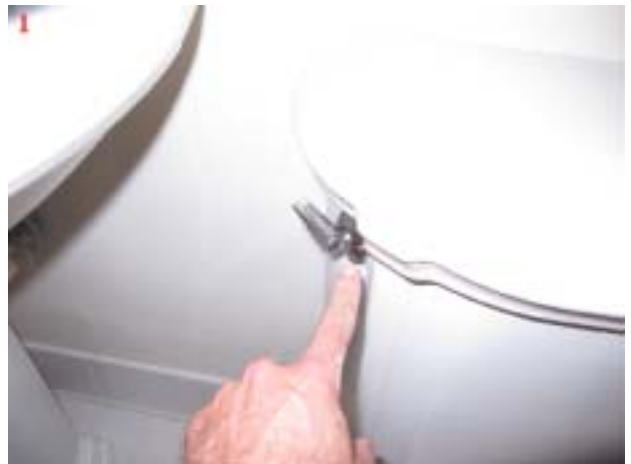
#2 Bathroom Toilet - 2 Piece, Operated

Flush lever is loose to the toilet. Repairs needed.

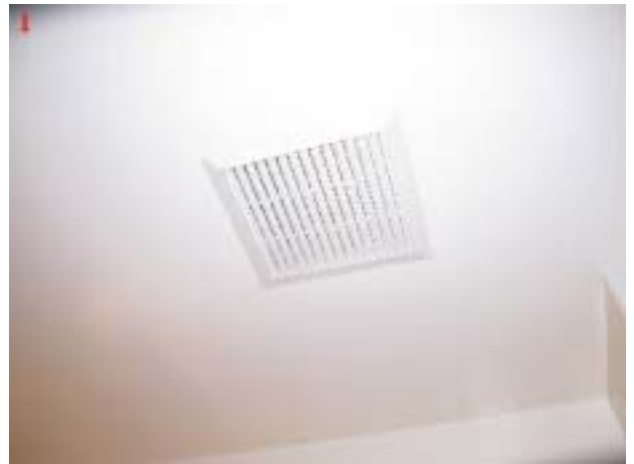
#2 Bathroom Ventilation - Exhaust Fan

Exhaust fan is aged, loud but operable. Near end of life.

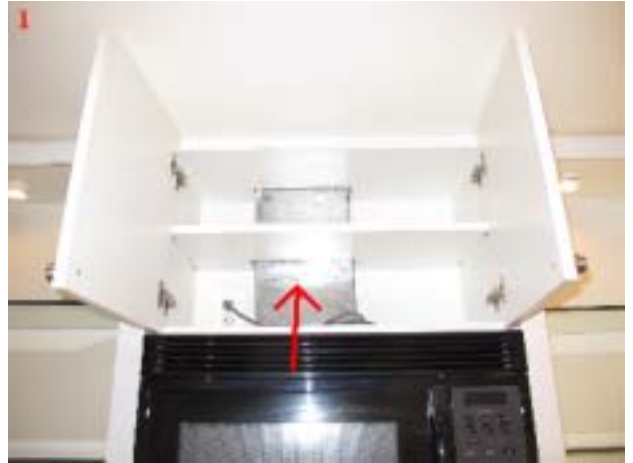
Ventilator - Microwave Exhaust, Vented to Outside Type

Not known where the end discharge is for this vent. Further investigation needed. Needs to vent outside.

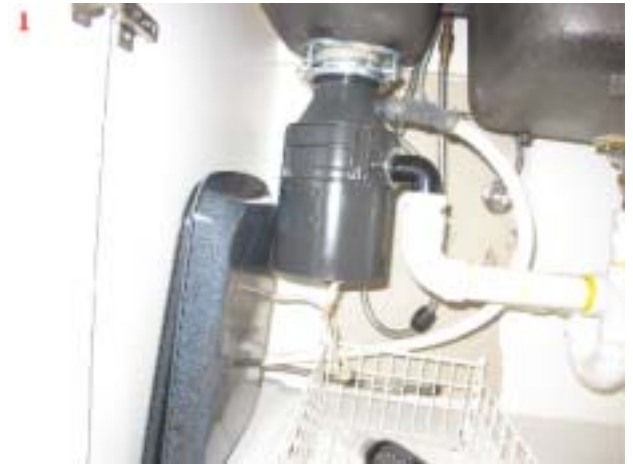
Garbage Disposal - Defective

Aged disposal is loud, rough and clattering. Not normal operation. Repairs or replacement needed.

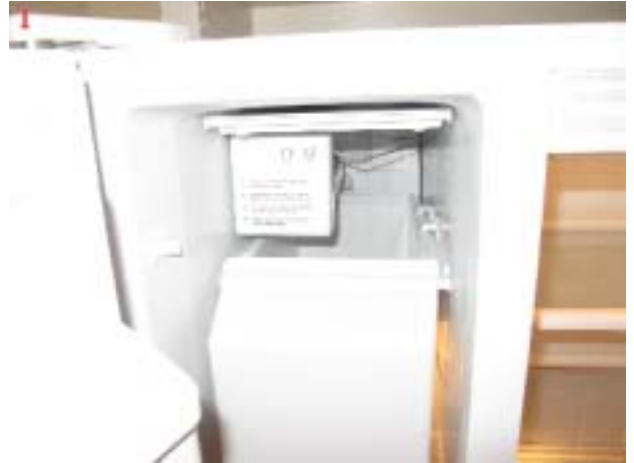
Kitchen Refrigerator - Operating, Ice Maker, Water Dispenser

The ice maker was off. Not known if the unit operates.
The ice maker should be turned on and fully operational at the buyers walk through.

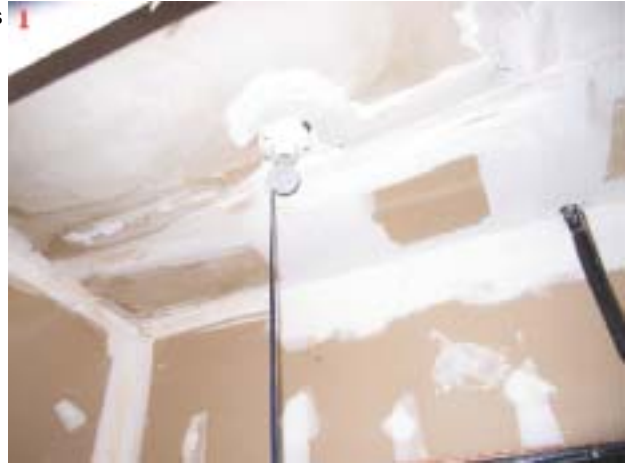
Living Space Ceilings #1 - Dry Wall

Patio storage room sheet rock ceiling has damage due to past leaks from above. Sheet rock repairs and paint are needed.

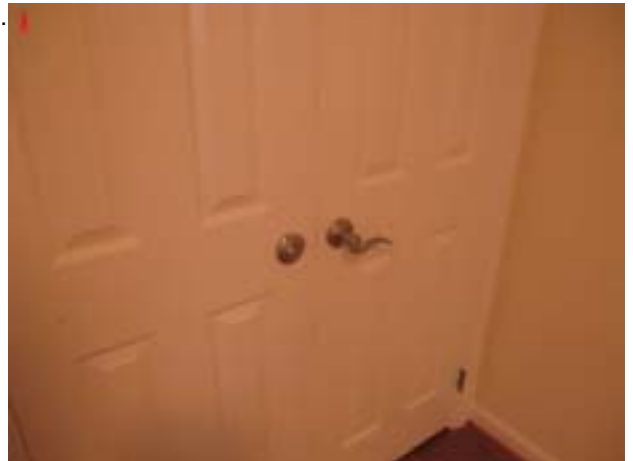
Middle bedroom, closet door is missing a knob. Repairs

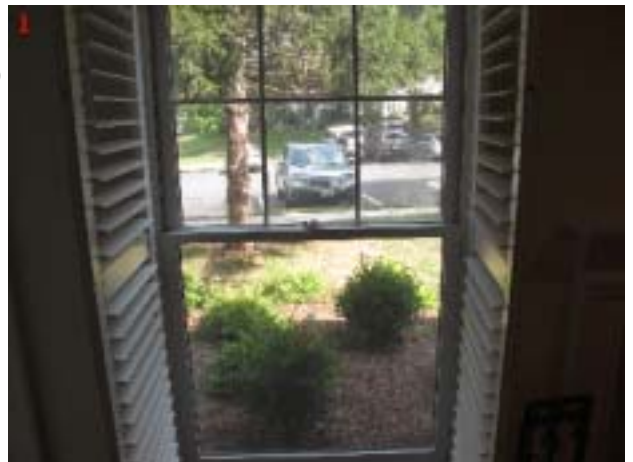
Living Space Windows #1 - Wood Double Hung, Insulated Glass

Living room windows.

- One window is missing a screen
- Both windows have missing decorative mullions. (See Picture #1)
