Schwindt & Company
7714 Carroll Avenue
Takoma Park, Maryland 20912
301 270-3554 www.schwindtco.net
rob@schwindtco.net email
ASHI, FREA, NEHA Certified
MD & VA Licensed

Printed Wednesday, August 29, 2012

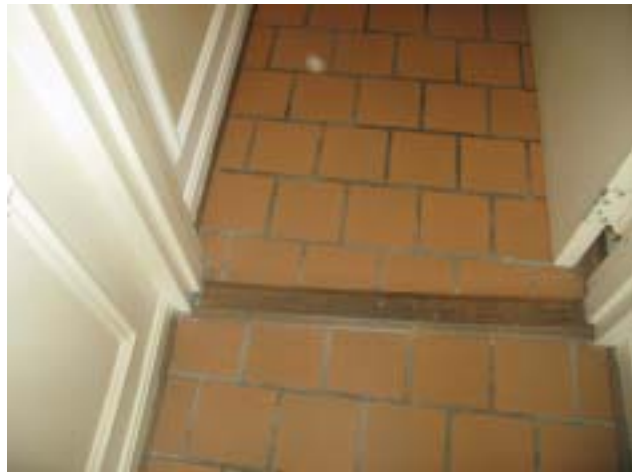
Wood threshold under the unit front door is loose to the floor.
(safety) Needs to be secured.

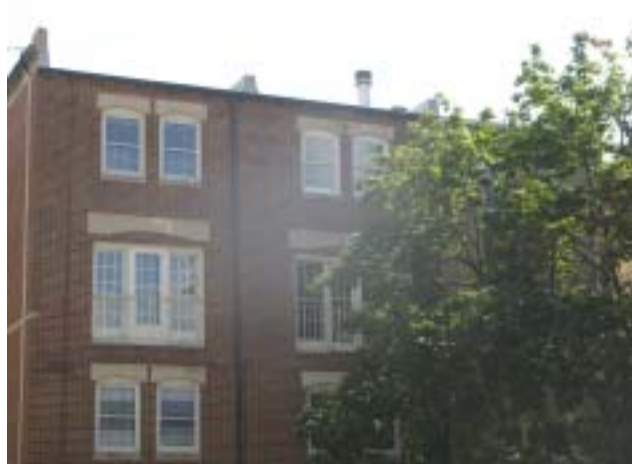
Exterior wall surfaces were only viewed as they pertain to this unit. Entire building was not observed.

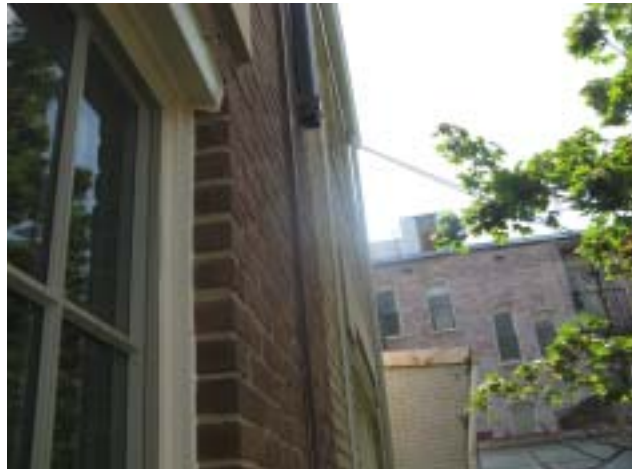
The buildings rear down spout has section missing and roof water can run down the rear building wall.

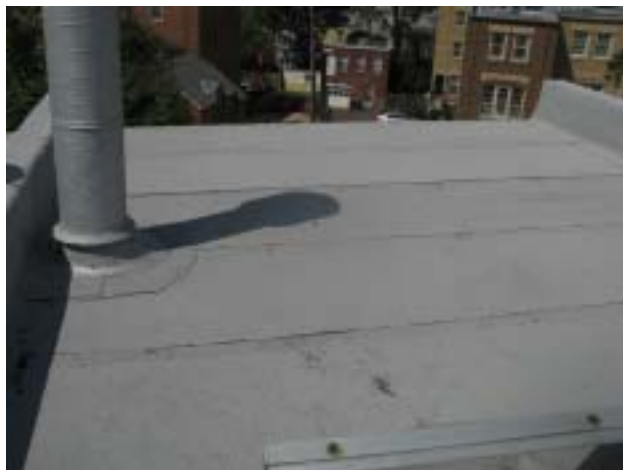
Roof surface over the unit is modified bitumen, single ply material. Looks nearly new. Typical life 12-15 years. Looks professionally installed.

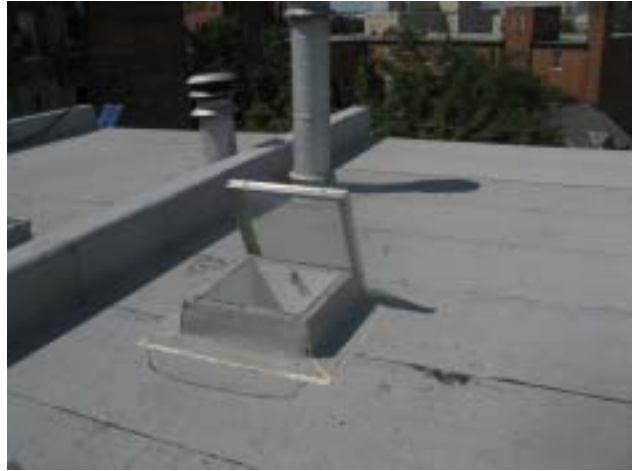
Removing the skylight is way to access the roof. Locks need to be installed to prevent access to the unit from the roof. (security issue) Repairs needed.

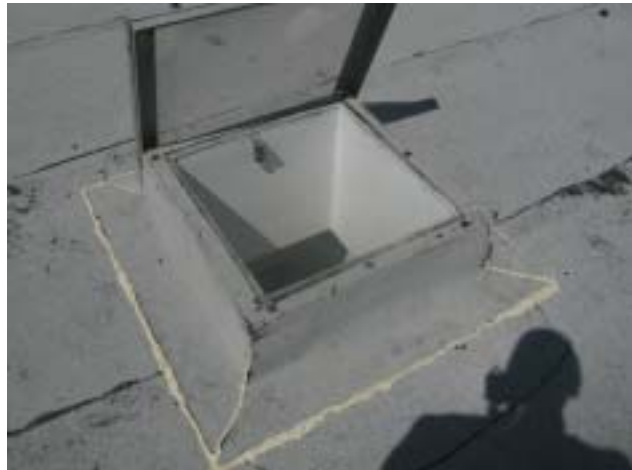
Signs of caulk repairs to skylight curb flashing were seen. Repairs look proper.

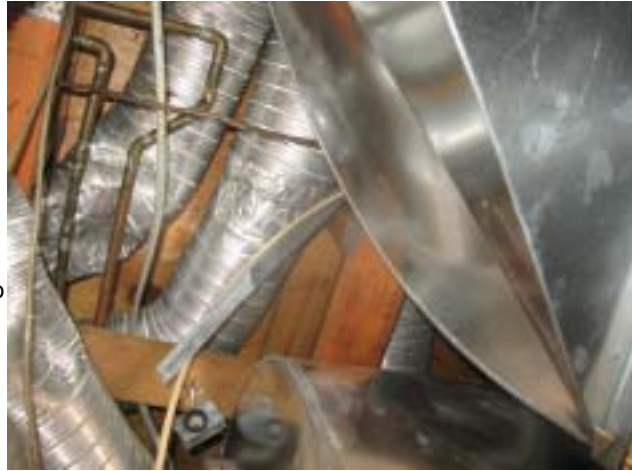
Small view of floor structure seen in the air handler room ceiling.

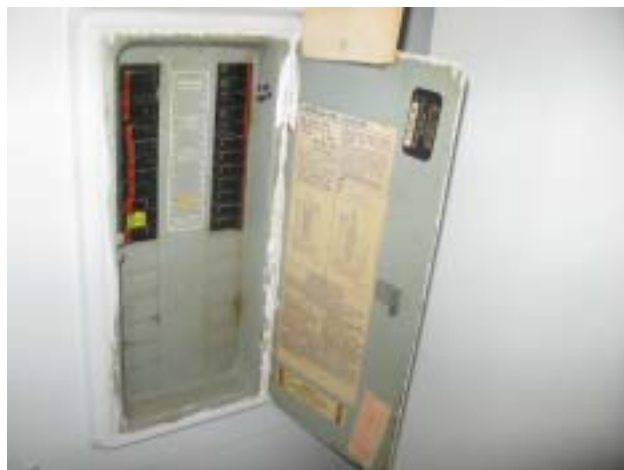
Panel was made by "Federal Pacific". This company is no longer in business. Their panels are poor quality and are often considered to be unsafe.

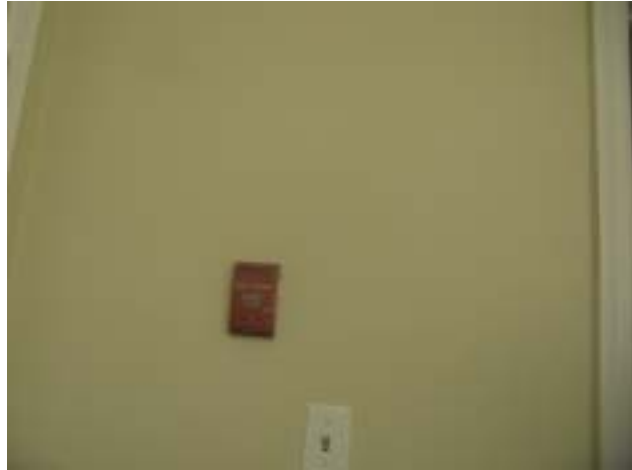
Building Fire Alarm Systems are not within the scope of the inspection.

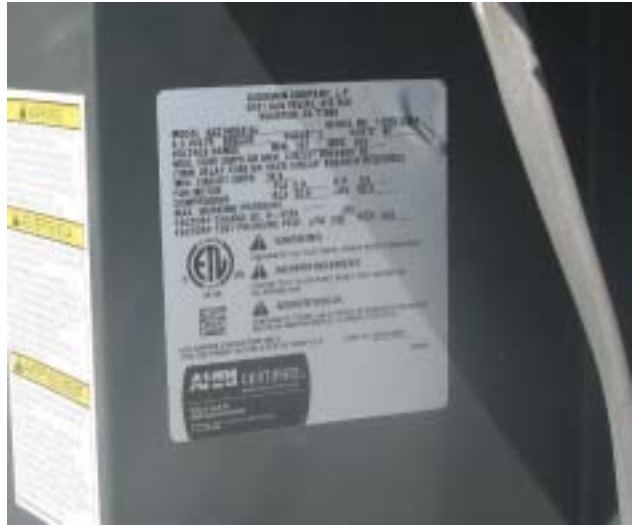
No manufacture date. Serial number suggests that the unit was constructed on 11-07

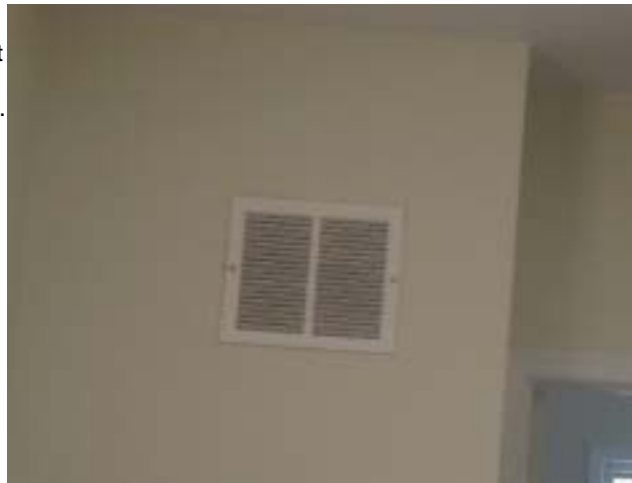
The top level return register is not designed to accept a filter. No filter installed. Repairs needed.

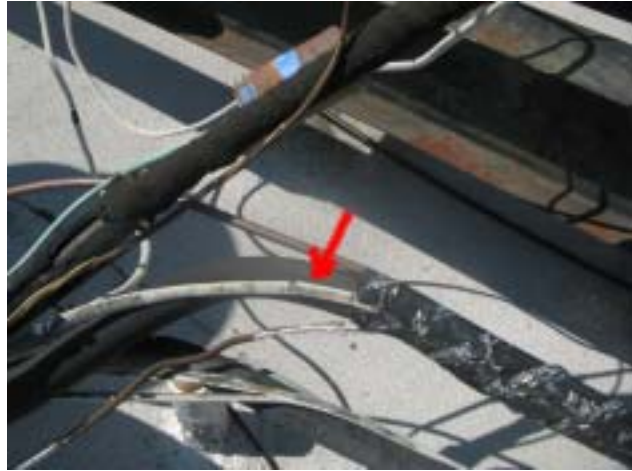
Electrical cable that provides power to roof mounted condenser unit has damaged outer jacket. (safety) This wire needs to be replaced.

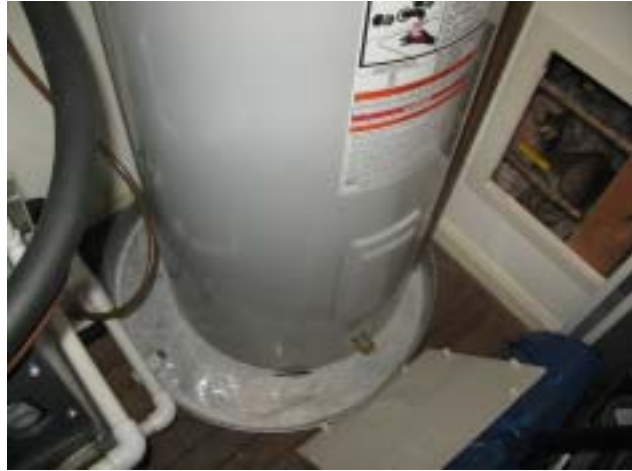
Safety leak pan installed but pan not connected to a drain. Will not serve function.

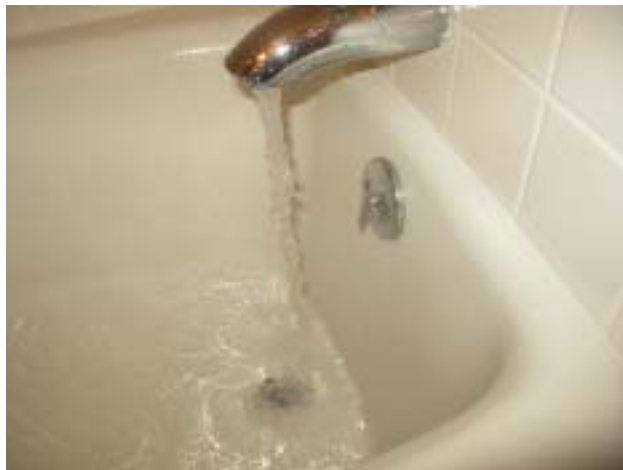
Tub stopper is not operating. Repairs needed.

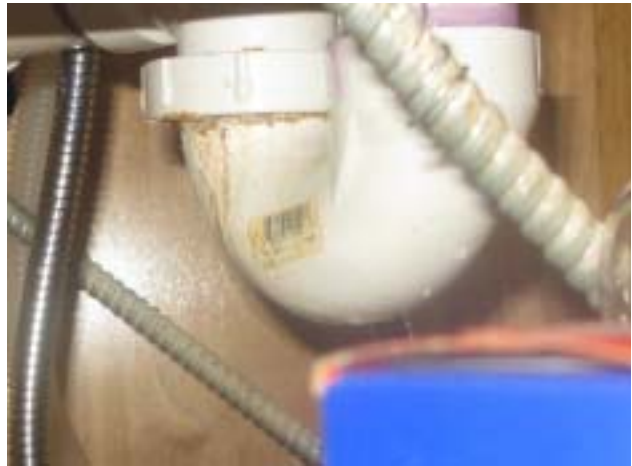
Signs of past leaking at sink drain assembly. No dripping at inspection.

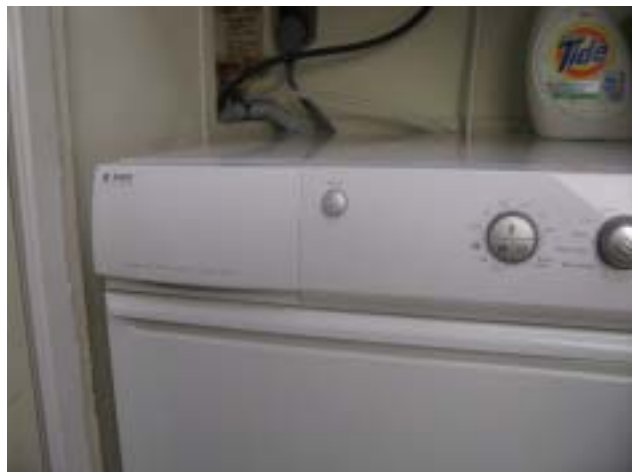
Clothes washer was not operational. Repairs or replacement needed.

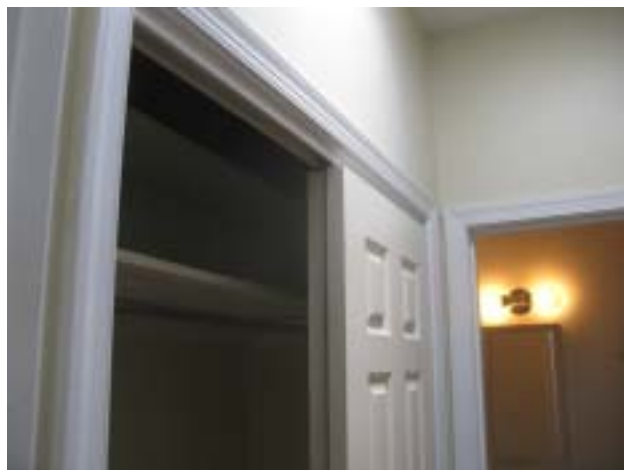
Master closet doors drag the ground and are hard to operate. Suspect this may be due to floor typical floor settlement. Repairs and adjustments needed.

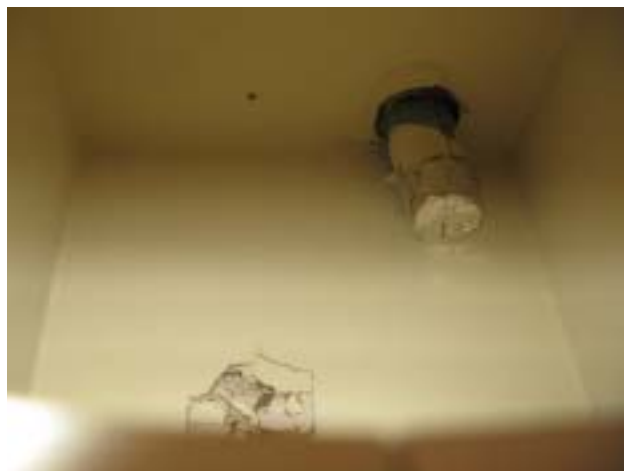
Section of sheet rock walls are damaged at rear laundry room wall. Cosmetic repairs are needed.

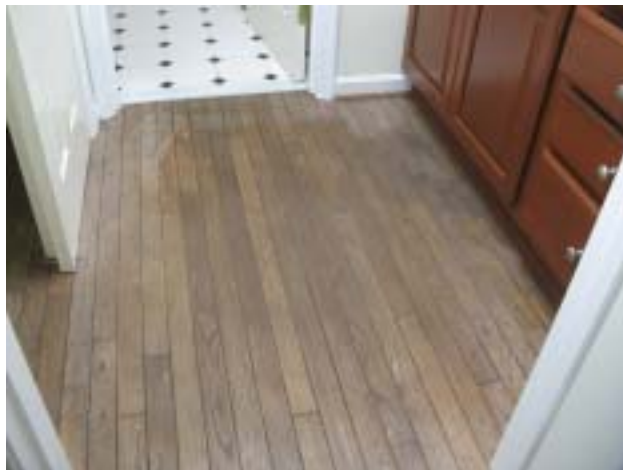
Upper level wood floor finish surface is worn and aged.
Refinishing is needed.

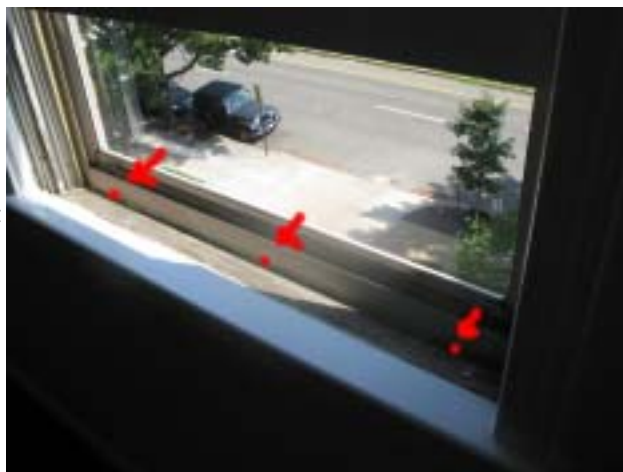
All storm window frames need drain holes added. All original sills need to be painted.
