**Schwindt & Company**  
division of Artisan Style, Inc.  
7714 Carroll Avenue  
Takoma Park, Maryland 20912  
301 270-3554 [www.schwindtco.net](http://www.schwindtco.net)  
[rob@schwindtco.net](mailto:rob@schwindtco.net) email  
ASHI Certified, MD & VA Liscensed

Client Information:  
**OLD, RENOVATED HI-RISE CONDO SAMPLE REPORT**

### (PI) PROPERTY INFO. - Condo Interior Inspection Only

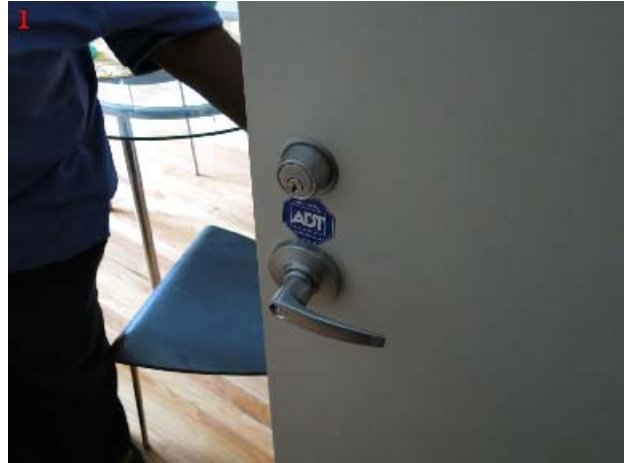
#### Unit Entry Door/s - Observed

Unit entry locks are hard to operate and need repairs.

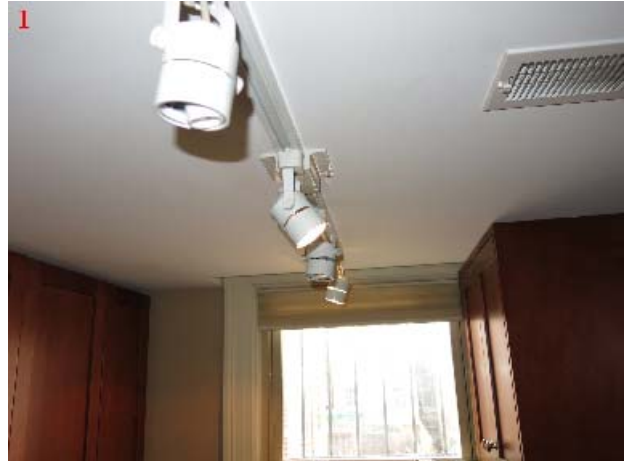
#### Lights/Ceiling Fans/Switches - Inspected

Kitchen ceiling has several track lights not operating. Some fixtures are damaged. Repairs needed.

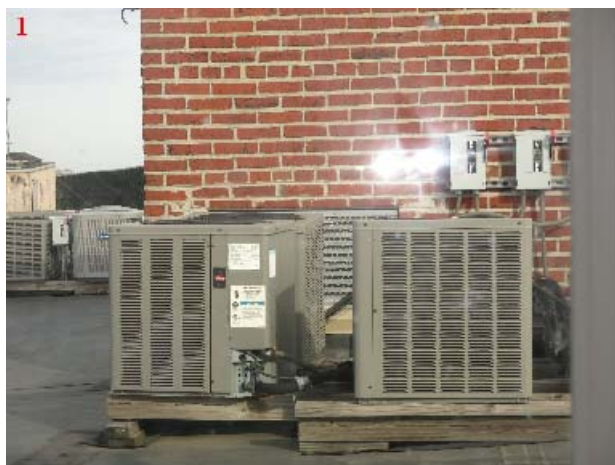
### #1 (AC) Condensor/ Compressor - Roof Unit

The building unit condensers are located on the attic. Inspector attempted to view the unit but the roof door was locked. The condenser was not viewed. Picture is of some condensers taken by looking through window.

Further investigation is needed on how to get to the roof.  
Contractors servicing the air conditioner will need to access the roof to perform service.

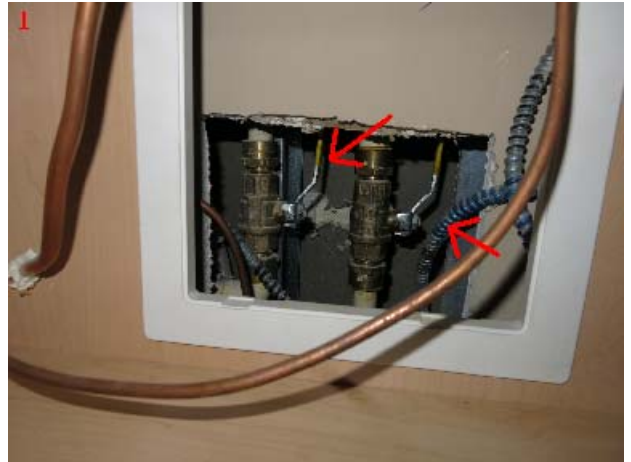
#### Main Water Shut Off - Under Kitchen Sink

A hot and cold water unit shut off valves were seen behind a hatch, below the kitchen sink.

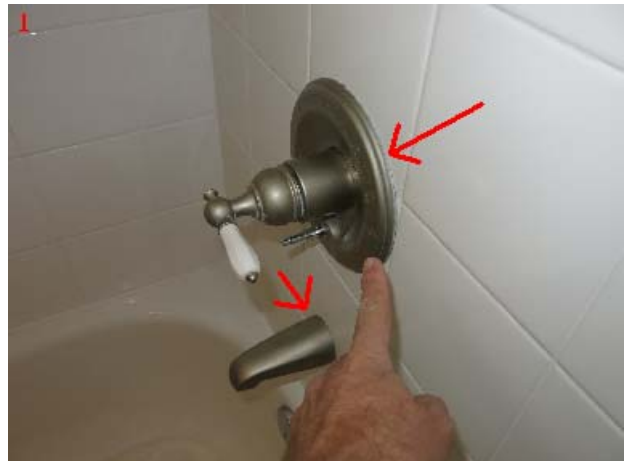
#1 Bathroom Tub Surround - Tile

Shower mixer escutcheon trim and tub spout need to be caulked to the wall, to keep water from entering behind the wall.

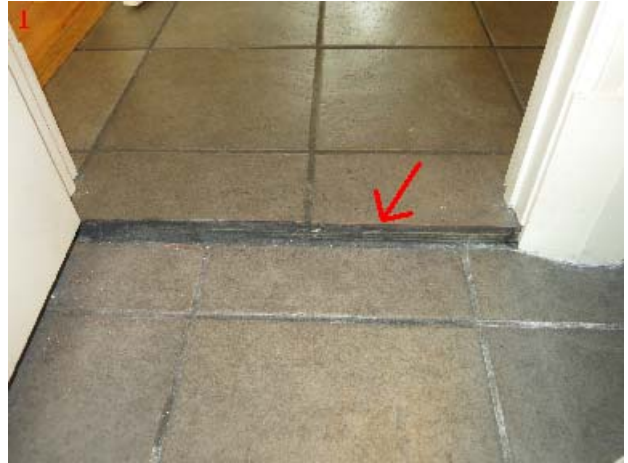
#### #1 Bathroom Floor - Ceramic

Kitchen tile floor is raised above the bathroom floor by more than one inch. The raised edge is a trip hazard. (safety) The sharp edge of the tile at the raised edge could cut or injure feet. (safety) Some type of ramped transition needs to be installed here.

Inspection and repairs are needed by a licensed Contractor.

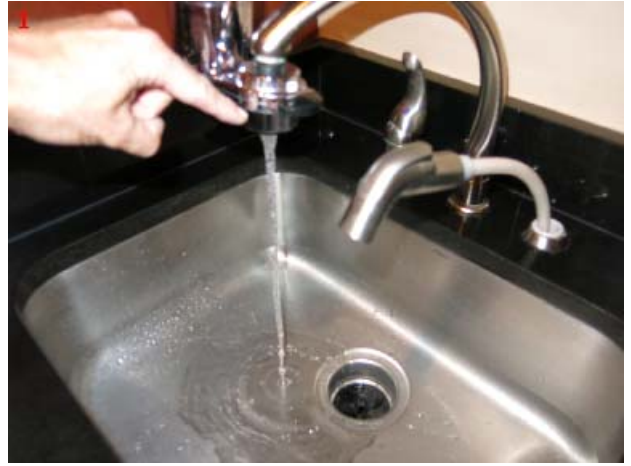
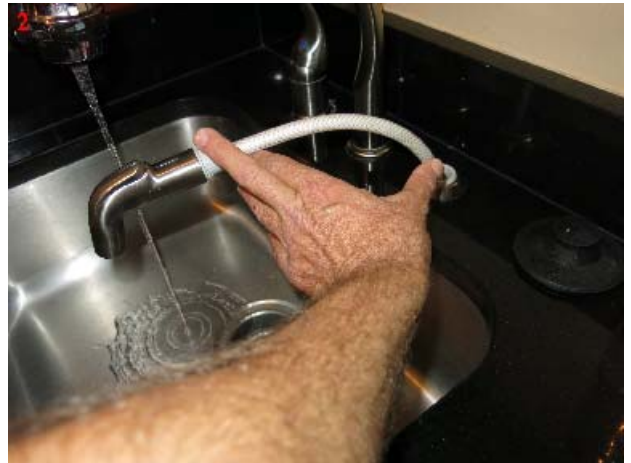
#### Kitchen Sink/Faucets - Stainless

1. Sink faucet has inadequate water flow. Repairs needed. (See Picture #1)
2. Sink spray is not fully extending. No usable. Repairs needed. (See Picture #3)

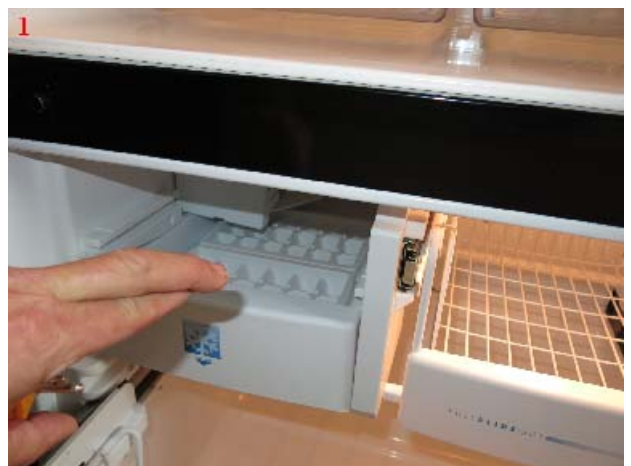
#### Kitchen Refrigerator - Operating, Ice Maker

Ice maker is not operating. Repairs needed.  
The ice maker should be turned on and fully operational at the buyers walk through.

Suspect water has been provided to the refrigerator. Multiple small tubing was seen under the kitchen sink.

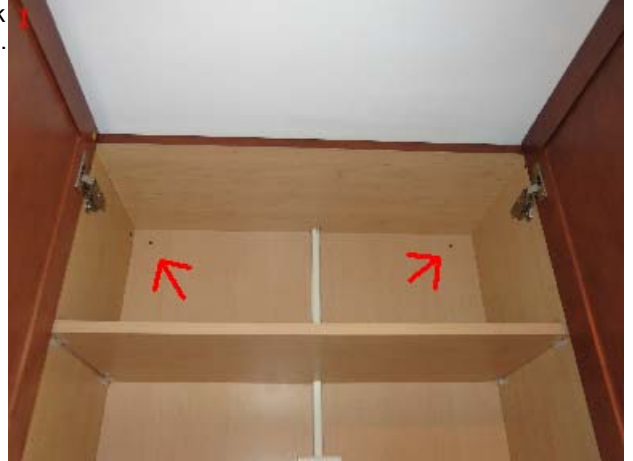
#### Kitchen Cabinets - Upper, Lower

Upper cabinets are connected to the wall using hardened sheet rock type screws. This is not proper because hardened screws are brittle. The heads could break off and the cabinet could fall. (safety) Softer, large headed screws are provided with most new cabinets and or available at hardware stores. Proper cabinet hanging screws need to be installed next to or below existing screws. Repairs needed.

Cabinets should be inspected and repaired as needed for safe and normal function by a licensed Contractor.

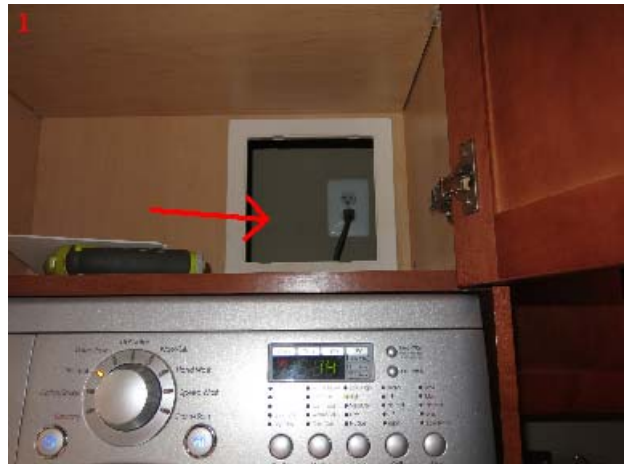
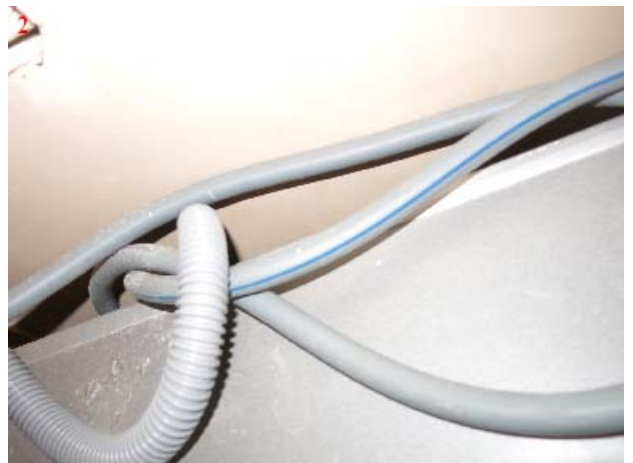
#### Hose Bibs (washer) - Not Viewed

Clothes washer shut off valves could not be viewed. Clothes washer shut offs are located behind the unit. The unit will need to be removed to turn off the water. Design flaw.

There is a panel in cabinet above the washing machine. No shut off viewed. Inspector took pictures inside the area but the shut off valves were not seen.

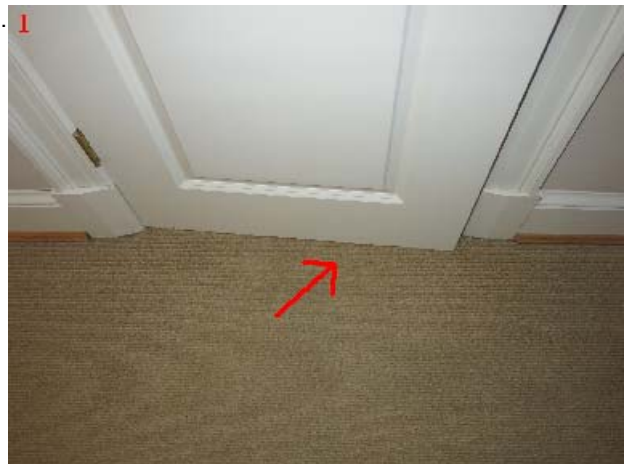
Living Space Doors #1 - Inspected

Door/s dragging the floor need to be trimmed for normal operation. The return air register for heating/cooling is in the hallway. All room doors need to be under cut 3/4 inch at door bottom to permit normal operation of the heating and cooling system.  
a. Bedroom door.

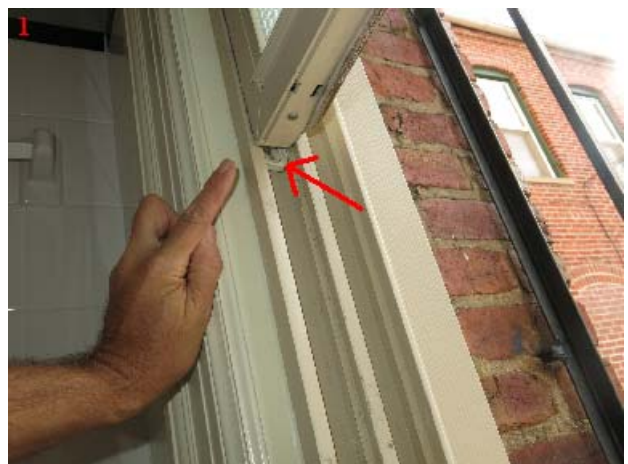
Living Space Windows #1 - Insulated glass, Vinyl Double Hung

Bathroom window sash is not properly connected to the lift spring and is difficult to operate. Repairs needed.  
Window has defective crank (not operable)

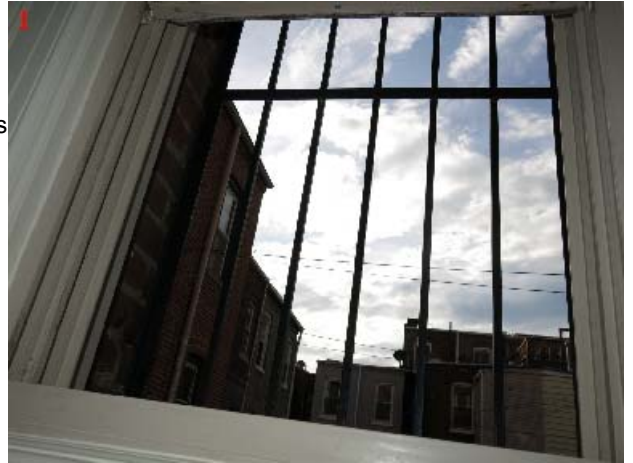
#### Window Screen/s - Some Missing

Some Screens Missing:

- a. Bathroom.
- b. Kitchen.

All screens should be installed and in normal condition at the Buyers final walk through.
