Inspected By:
Robert Schwindt

Client Information:
SAMPLE OLDER HIGH RISE CONDO REPORT

COVERPAGE

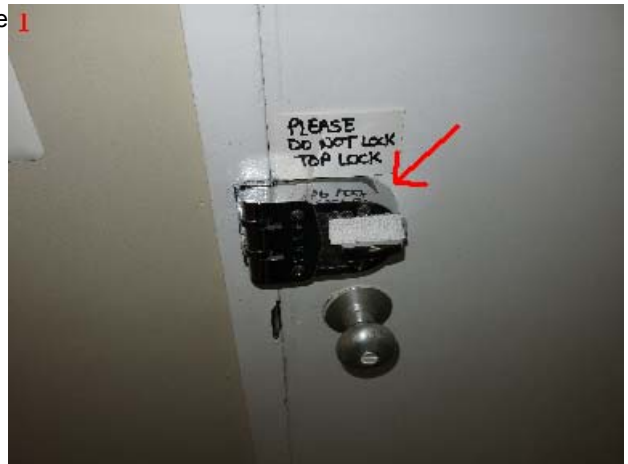
Unit Entry Door/s - Observed

1. Unit entry door has one lock, marked do not use. (unit/s should be in normal working order at Buyers final walk through) (See Picture #1)
2. Mechanical door bell on the entry door is not operating. Repairs needed. (See Picture #2)

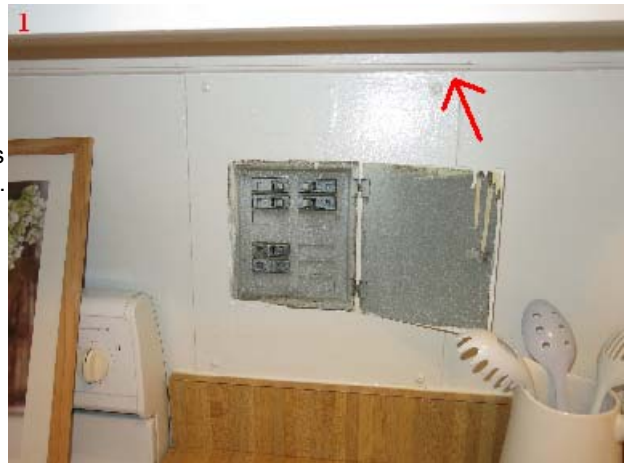
#1 Panel Type - Breakers

Unit electrical panel.
a. Breakers are not labeled. (safety) Repairs needed.
b. Paint over spray on the breakers could effect their function. (safety)
c. The cover could not be removed for inspection of box interior. Caulk and upper cabinet prevented removal. The panel cover needs to be removed and the panel checked for safe and normal condition.

Inspection and repairs needed by a licensed Electrician.

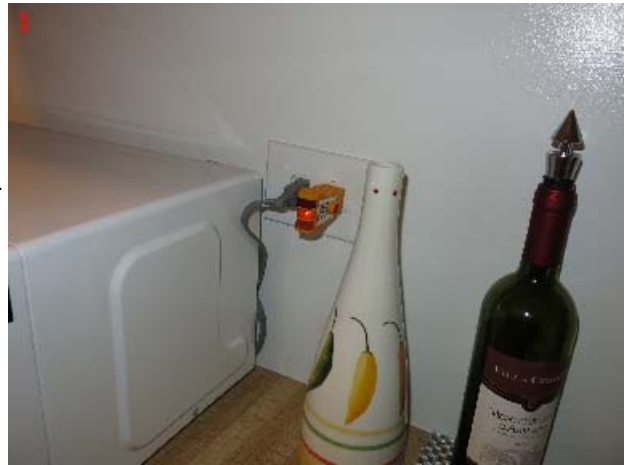
Interior Outlets - Inspected, Outlet Defects

Outlet/s with open ground (Safety) Repairs needed.
a. Kitchen near the microwave. (See Picture #1)

Outlet defects were discovered during the process of the inspection. All outlets should be inspected and repaired as needed for safe and normal function by a licensed Electrician.

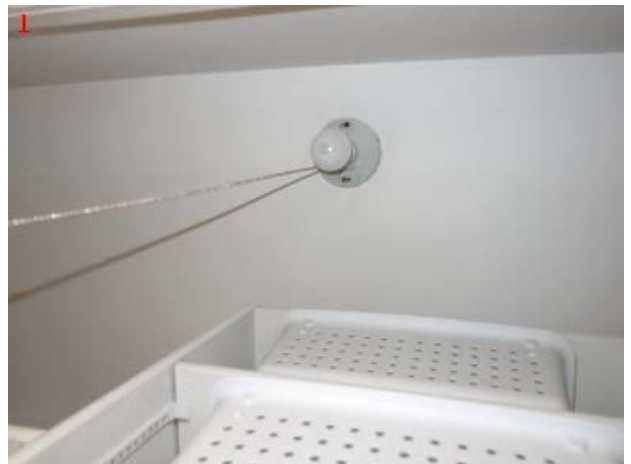
1. Incandescent bulb fixtures are not safe for use in closets. They are a fire hazard.(safety) A proper closet fixture needs to be installed. Repairs needed.
a. Bedroom closet. (See Picture #1)

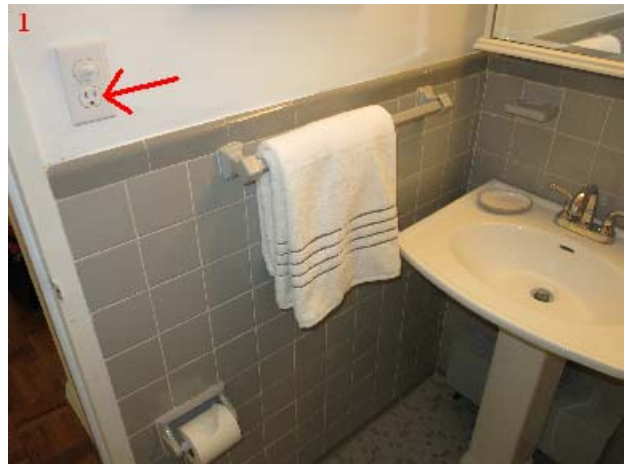
1. Replaced outlet in the master bathroom is not operating. Replaced outlets need to be GFCI protected. (safety) Repairs needed. (See Picture #1)
2. The kitchen has been modernized and the outlets within six feet of the kitchen sink have not had GFCI protection added. (safety) Repairs needed. (See Picture #2)

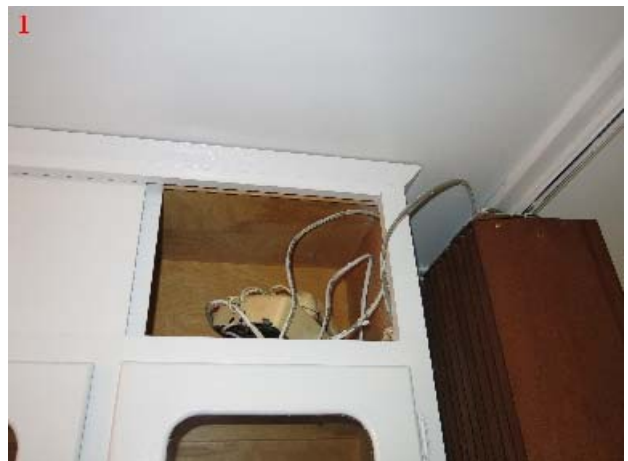
Old telephone in kitchen cabinet. Wires are hanging out of the cabinet. The phone and wires should be removed or the phone should be properly installed. Buyer should be consulted.

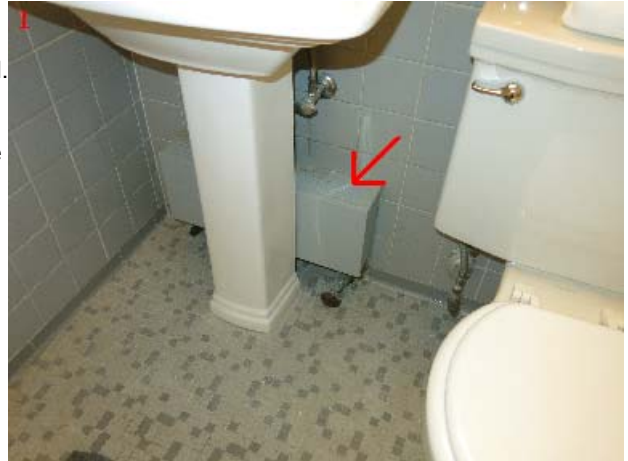
Unit radiators were not on at inspection. The unit heat cannot be controlled from the unit. The only control of radiators is the shut off valve on the unit. The function of the radiators could not be checked.

1. Small radiator in bathroom. Not operable due to season. Not known if this will work. Needs to be checked when the heat from the building is on. Further investigation needed.

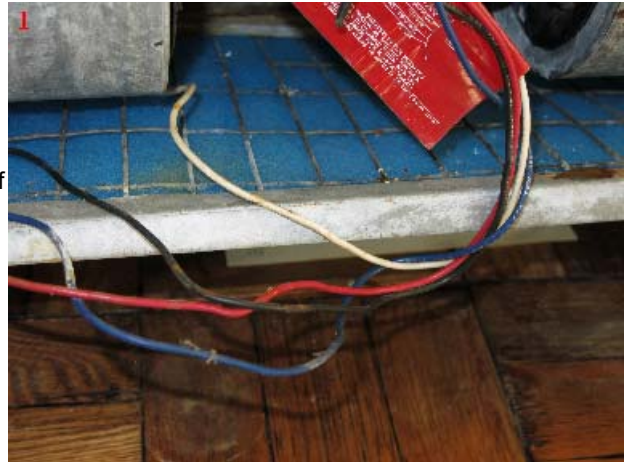
Master bedroom unit.

1. Loose electrical wires were seen in the blower box. (safety) wires need to be installed into some type of conduit or wire wrap. Repairs needed. (See Picture #1)

The convector/s need to be inspected, repaired and serviced by a licensed plumber or HVAC contractor.

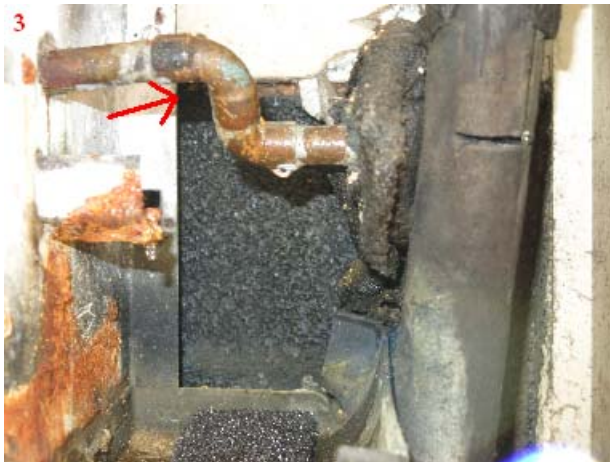
2. Condensation water was dripping down into the blower box. Repairs needed. (See Picture #2)

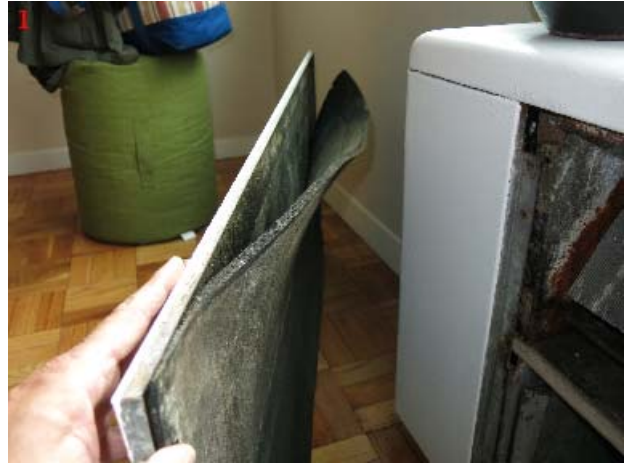
Living room Convector.

1. Insulation on the removable cover is loose and needs to be secured. (See Picture #1)

The convector/s need to be inspected, repaired and serviced by a licensed Plumber or HVAC contractor.

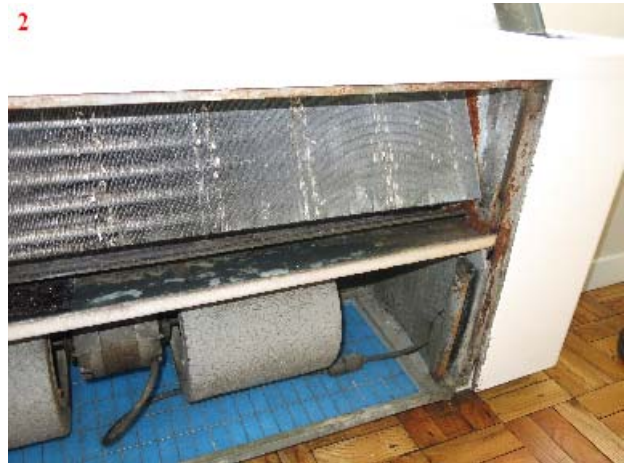
2. Unit coils and drip pan need to be cleaned. (See Picture #2)

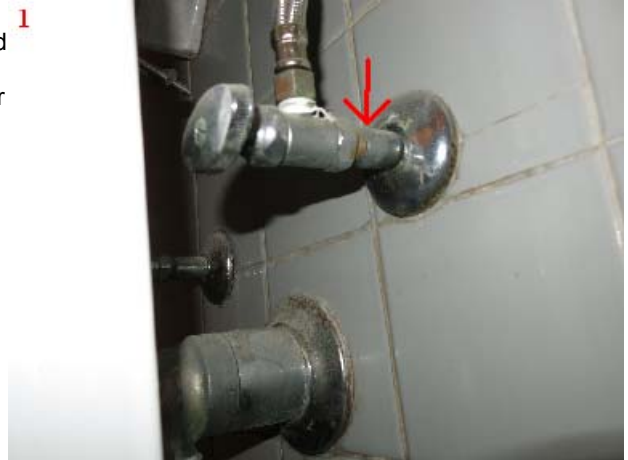
Galvanized steel piping is very old and near end of service life. ¹
Some of the unit water pipes are aged steel pipes. The buyer should consult with the association regarding who will be responsible for water pipe replacement when these aged pipes fail. Bathroom water pipes. (See Picture #1)

Pipes leading to the kitchen have been changed to copper.

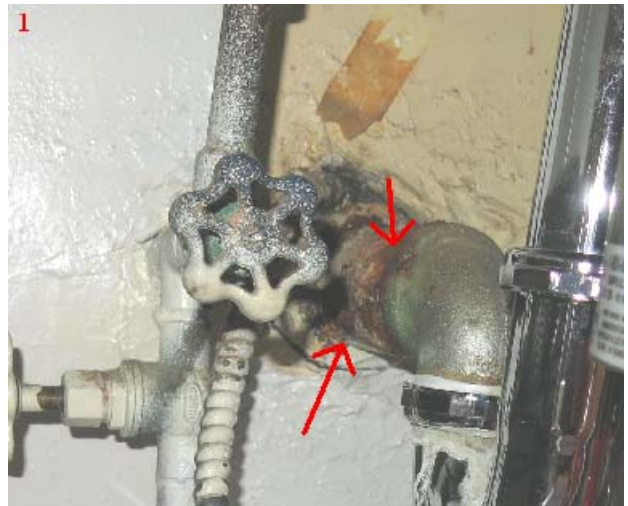
View of Interior Waste Pipes were limited by:
Closed walls and ceilings limit view.
Galvanized steel water pipes have a Typical life of steel drain pipes is 35-50 years. Any steel drain pipes remaining are aged past expected service life.

1. Steel drain pipe below the kitchen sink has rust damage and is failing. Pipe replacement is needed. (See Picture #1)

Inspection and repairs are needed by a licensed Plumber.

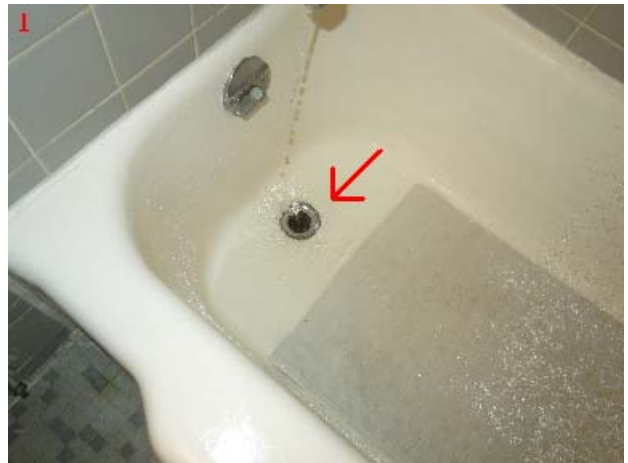
1. Tub stopper is not operating. Repairs needed.
2. Tub drain is obstructed and needs to be cleared or repaired.

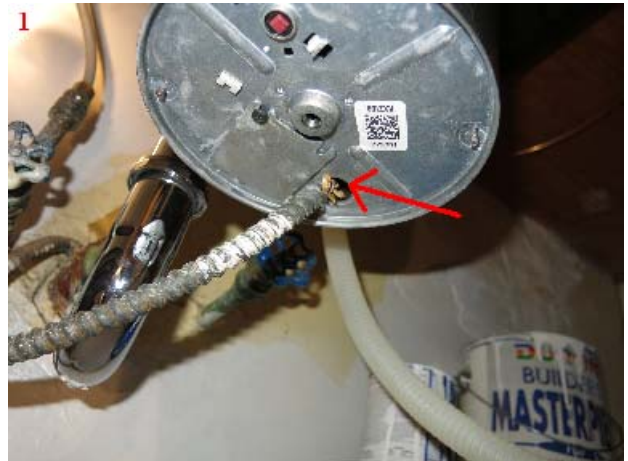
1. Wire enters disposal, not through approved connector. (Safety)
Repairs needed.

The Inspector forgot to note if the disposal works. This unit should be repaired and in normal working order at the Buyers final walk through.

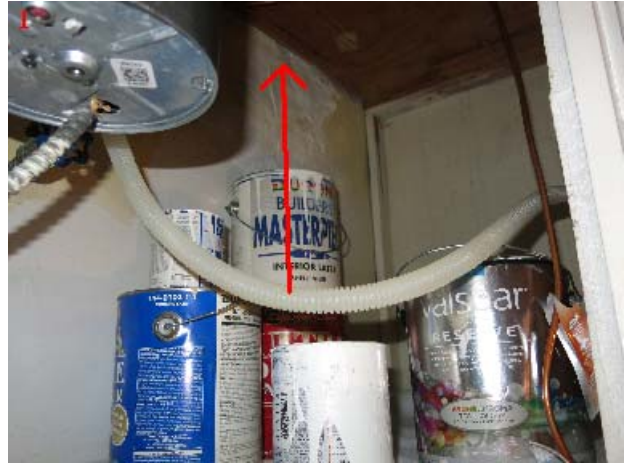
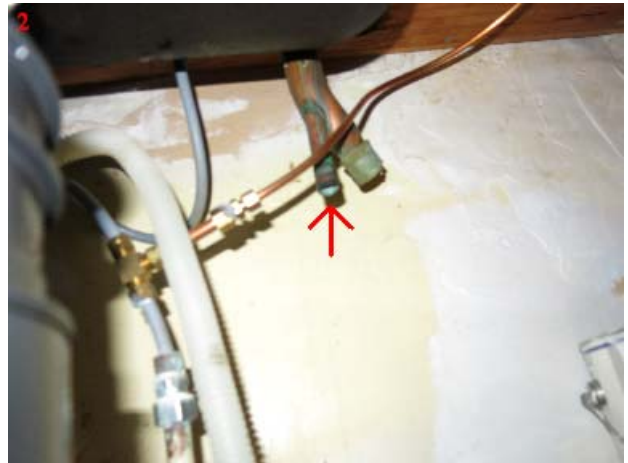
The drain hose is not connected to the air gap. The drain hose from the dishwasher needs to be looped up in the sink base cabinet as close to the counter top as possible and secured there. (Health/Safety) This is needed to prevent dirty water from the disposal from entering the dishwasher.

Or the drain hose can be connected to the existing air gap. (See Picture #2)

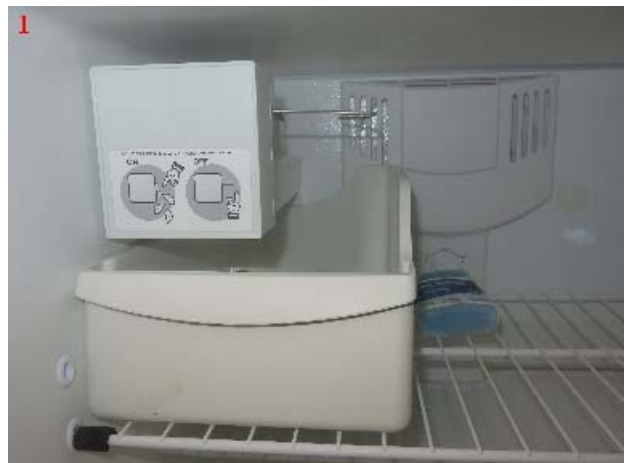
Ice maker was turned off at inspection. Not known if the unit is operating.

The ice maker should be turned on and fully operational at the buyers walk through.

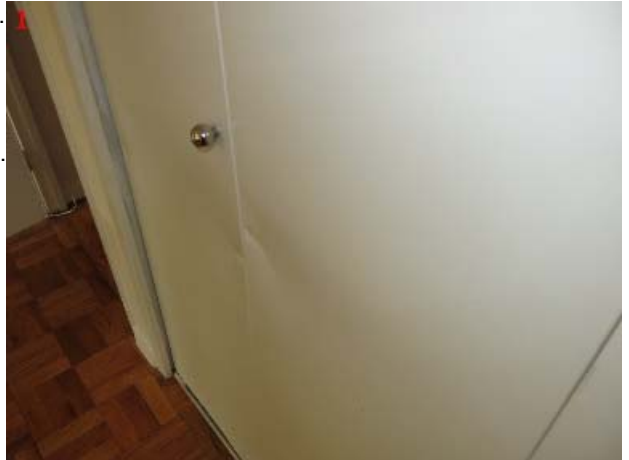
1. Bedroom closet doors are dented but function. Cosmetic issue.
(See Picture #1)
