**Schwindt & Company**  
division of Artisan Style, Inc.  
7714 Carroll Avenue  
Takoma Park, Maryland 20912  
301 270-3554 [www.schwindtco.net](http://www.schwindtco.net)  
[rob@schwindtco.net](mailto:rob@schwindtco.net) email  
ASHI Certified, MD & VA Liscensed

Client Information:  
**Newer CONDO in Multi-unit Building Sample Report #1**

# Inspection Report Details

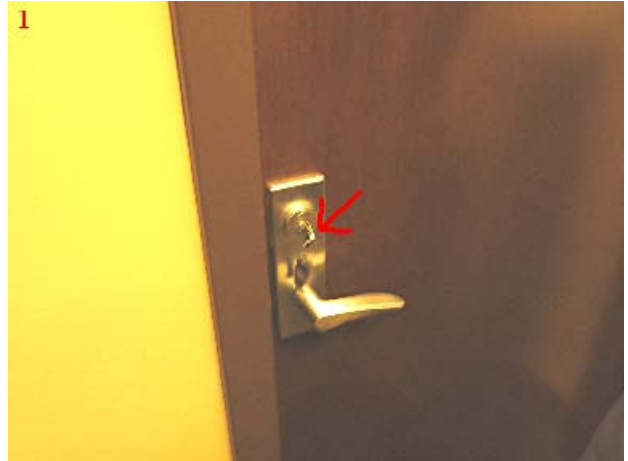
#### Unit Entry Door/s - Operated

Unit entry door is difficult to open, due to poor key function. Repairs are needed.

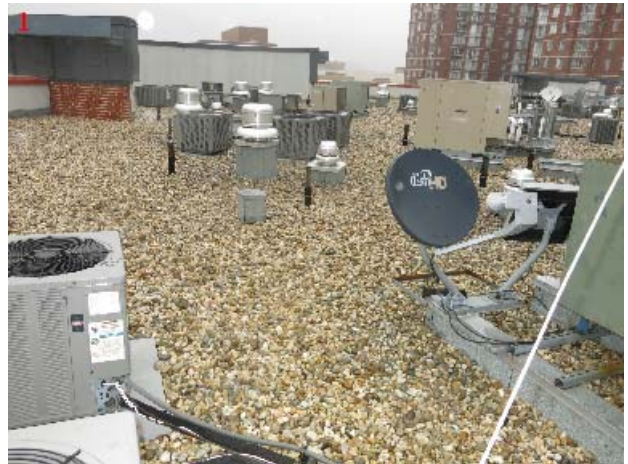
#### Roof - Roof Comment

Roof Comment:  
Cursory view of the roof when the inspector was on the roof to look at the condenser unit.  
Building roof surfaces are not within the scope of this inspection.

Some type of built up roof covering with gravel top surface. Typical life of 15-20 years.

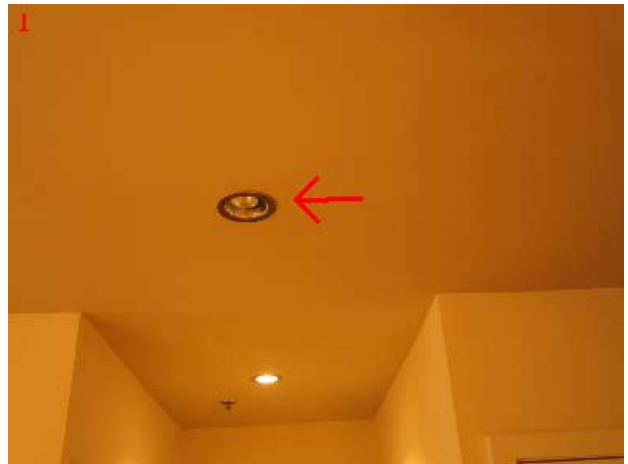
#### Lights/Ceiling Fans/Switches - Inspected

Light is not operating, Bulbs?  
a. Bath hallway. (See Picture #1)  
b. Master closet.  
(unit/s should be in normal working order at Buyers final walk through)

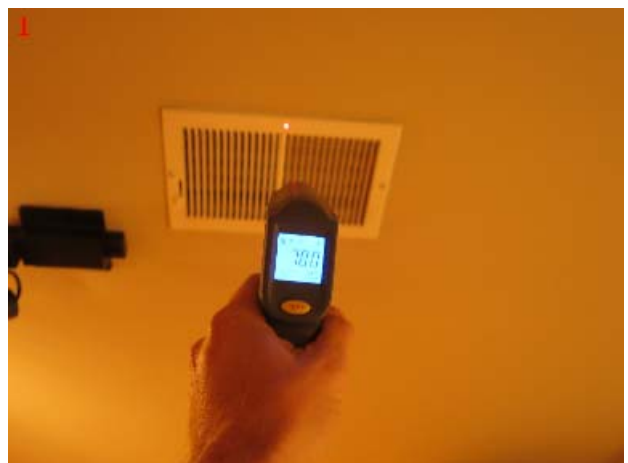
#### #1 (HP) Back Up Heat - Not Fully Heating

Back up electric coil heating system is under heating. Repairs needed.  
Repairs/Service needed by a licensed HVAC contractor.

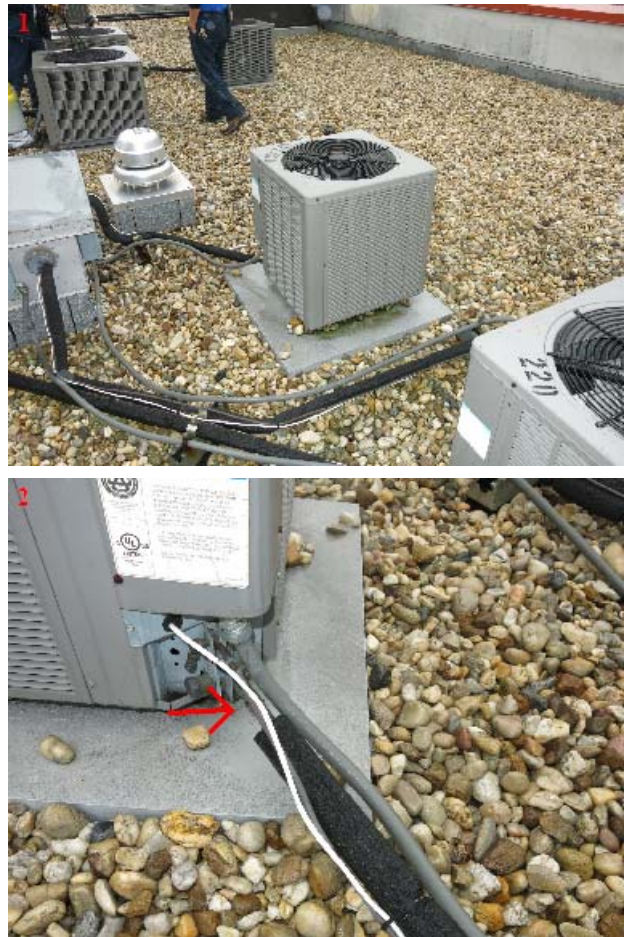
#1 (HP) Condensor/ Compressor - Roof Unit

1. Coolant line insulation is aged and cracking. The insulation was cut four inches short. This will cause loss of efficiency. Repairs needed. (See Picture #2)

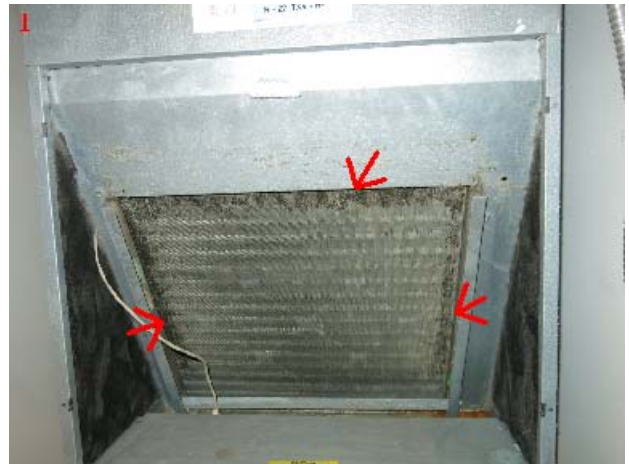
#### #1 (HP) Air Handler - Inside Unit

Exchange coils in the air handler are dirty and need to be cleaned for the system to have normal function. (See Picture #1)

Repairs and service should be by a licensed HVAC contractor.

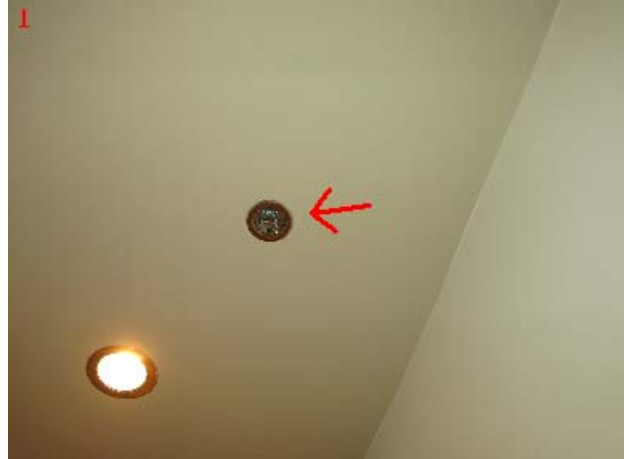
#### (PL) PLUMBING - General Comment, Fire Sprinklers, Plumbing in Unit Only

Fire Sprinkler systems are not in the scope of this inspection. The inspector will check for leaks. For more information regarding who services this system consult the seller or condo. (See Picture #1) Further investigation is needed to determine who the buyer would call in the event that a fire sprinkler would mistakenly turn on or fail.

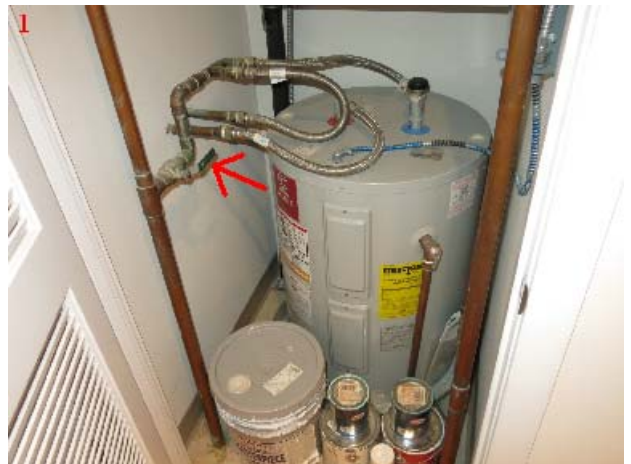
#### Main Water Shut Off - Near Water Heater

Valves are not operated as part of a home inspection.

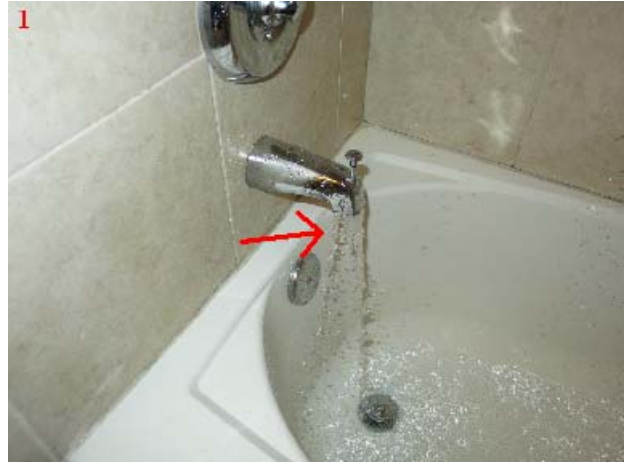
### #1 Bathroom Faucets - Sink/Tub

1. Tub spout shower diverter is not fully sending water to shower. Repairs needed. (See Picture #1)
2. Shower head is leaking at the head to arm connection. Repairs needed. (See Picture #2)

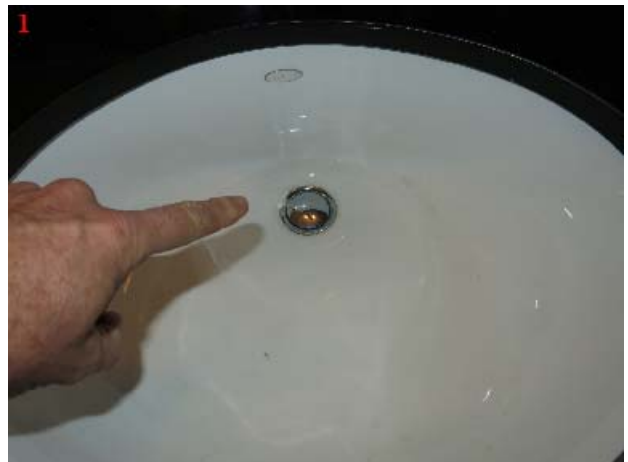
### #1 Bathroom Traps/Drains - PVC

1. Sink drain pop up is not operating. Repairs needed.

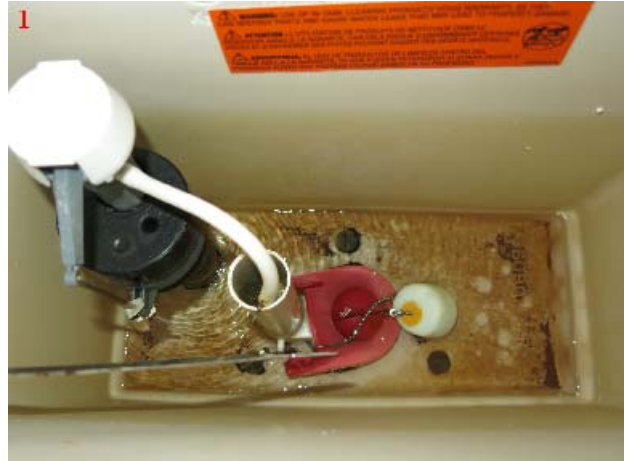
#### #1 Bathroom Toilet - 2 Piece

Toilet is running on and is not operable. Repairs needed

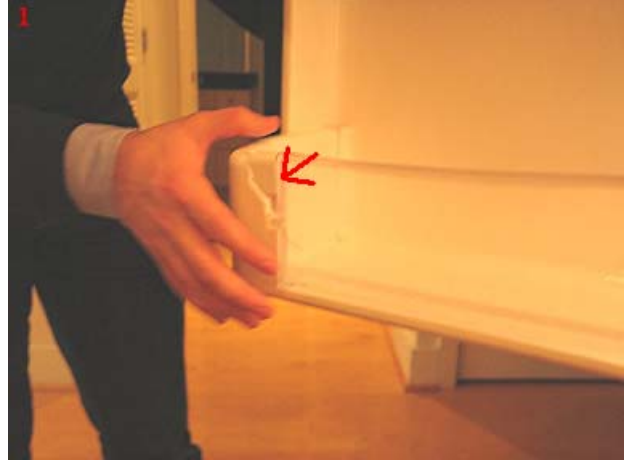
#### Kitchen Refrigerator - Operating, Ice Maker

1. One refrigerator door shelf is broken and needs to be replaced. Repairs needed. (See Picture #1)

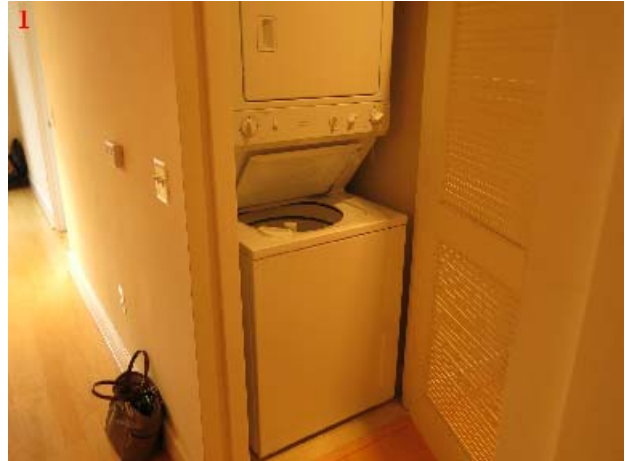
#### Clothes Washer - Washer & Dryer are Stacked Unit, Operating

Clothes washers are operated in a single mode only. cursory inspection only. Unit is checked to see that it fills, operates and drains. Tested in only one washing mode. Clothes washer is aged unit. Typical life 7-12 years.

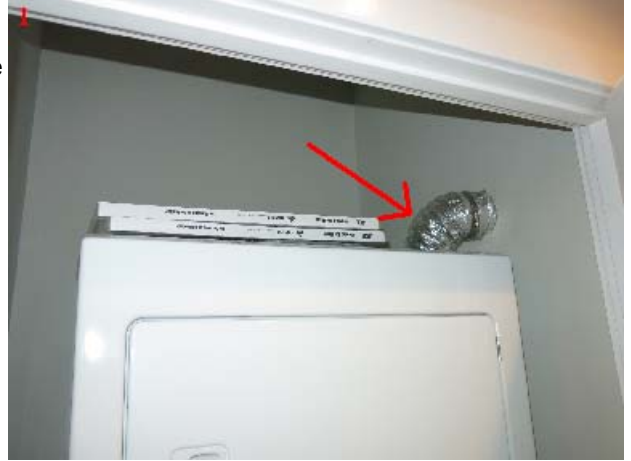
Dryer Vent - Vented

Dryer vent pipes need to be periodically cleaned of lint for normal and safe operation of the dryer. Further investigation is needed to determine when the vent pipe was last cleaned? Who is responsible for cleaning it? Condo? Owner?

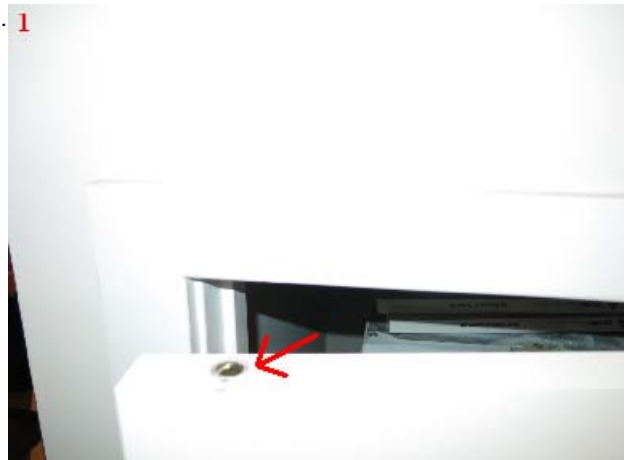
Living Space Doors #1 - Inspected

Doors not latching, repairs or adjustments needed.

a. The ball catch at the top of the laundry door is damaged and needs repairs. (See Picture #1)

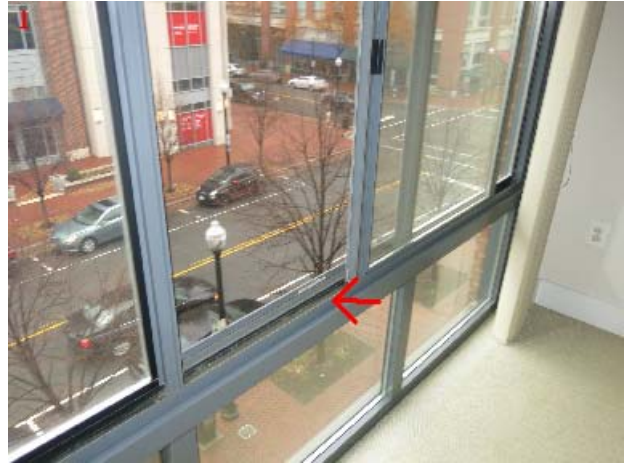
#### Living Space Windows #1 - Insulated glass, Metal Sliders

Windows are difficult to open, lubrication or adjustments needed.
