Schwindt & Company
division of Artisan Style, Inc.
7714 Carroll Avenue
Takoma Park, Maryland 20912
301 270-3554 www.schwindtco.net
rob@schwindtco.net email
ASHI Certified, MD & VA Liscensed

SAMPLE GARDEN STYLE CONDO REPORT #3

COVERPAGE

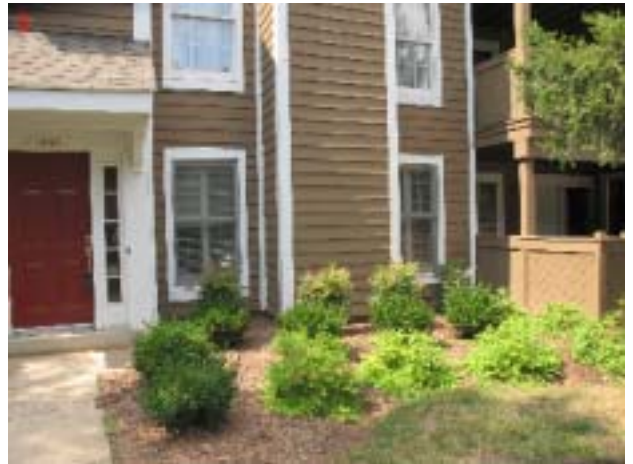
Exterior Wall Surfaces - Wood Siding, Pertaining Surfaces Observed

Only sections of the exterior as they pertain to this unit were observed. cursory inspection only.

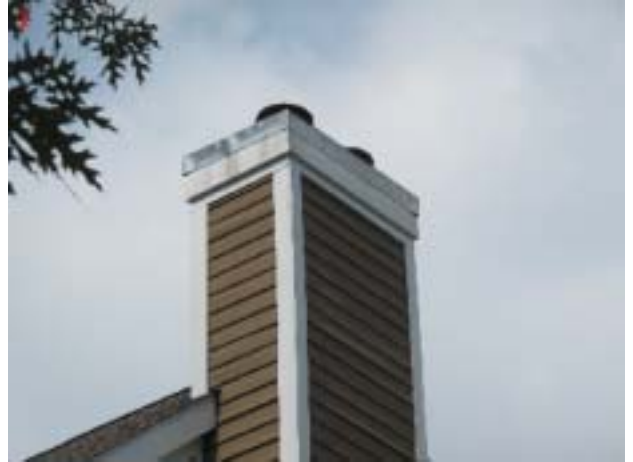
Chimney/s - Metal, Limited View

Chimney and Flue view limited by:
Height of chimney. Viewed from ground only. Limited view.
Metal flue pipe in wood sided chase box.

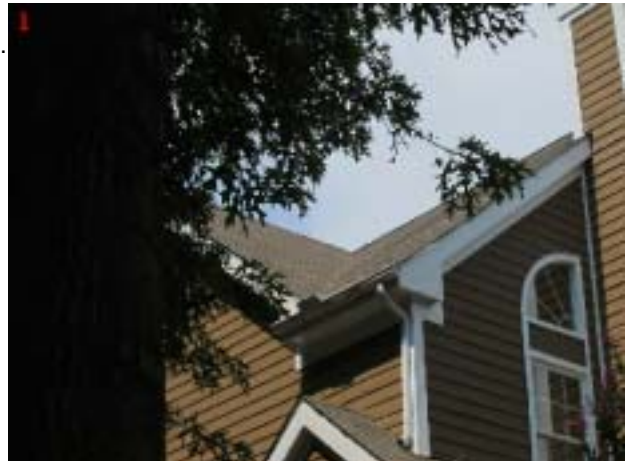
Roof - Roof Comment

Roof Comment:
Not a full inspection of building roofs/roof structure/gutters or spouts.
Cursory inspection only.
Viewed from ground with binoculars. Not all of the building roof surfaces were seen.
Asphalt shingles, Not at end of life. Suspect at least 5 years service life remains.

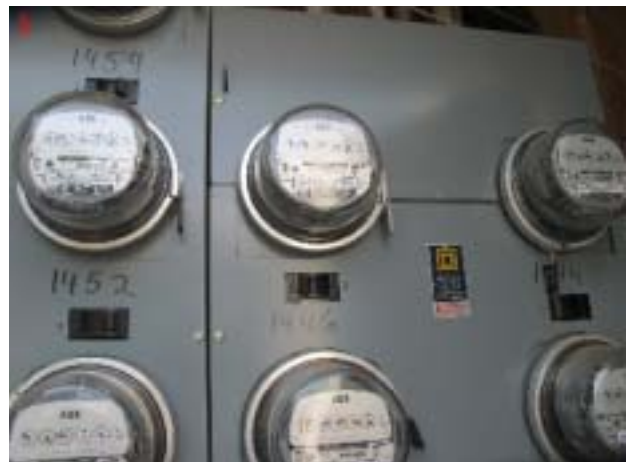
Main Breaker/Fuse Size - 150 amp, Unit Disconnect located in Building Meter Room

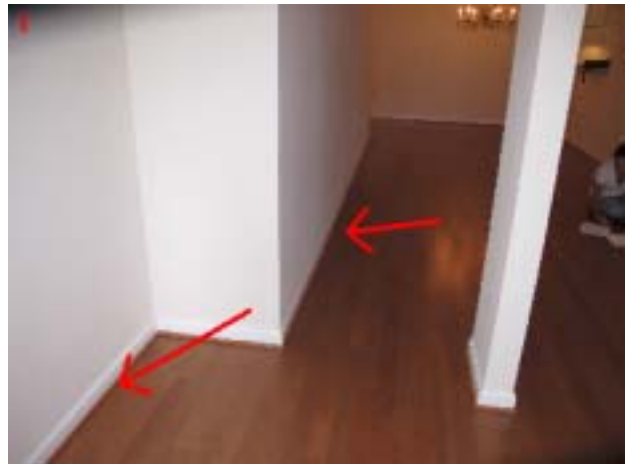
(BA) BASEMENT - General Comment

The left side of the living/dining room is below grade. No signs of seepage were seen on walls or flooring at this area. Some grading improvements are needed next to the left side of the building to move water away from the structure and reduce the risk of future seepage. Discussed in detail elsewhere in the report. The entire front of the unit is above grade. Rear not viewed, unknown.

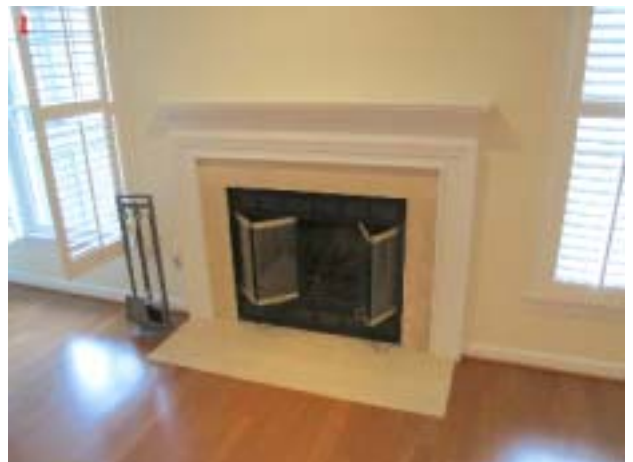
(FP1) #1 FIREPLACE/STOVE - General Comment

Fire places are not operated in scope of inspection.

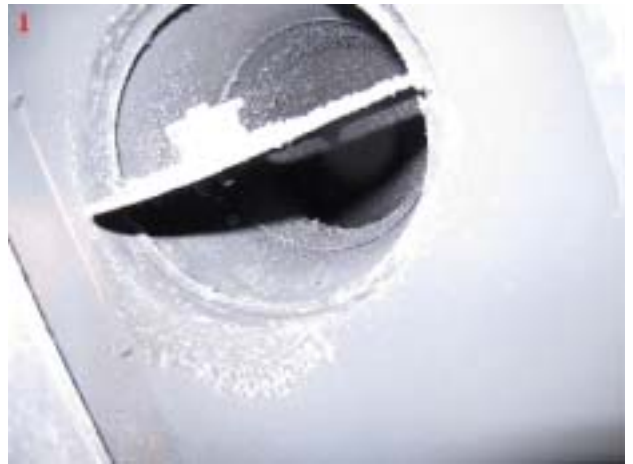
#1 (FP) Viewable Flue/Vent% - 25% View, Limited View

Due to flue configuration, the full flue vent could not be viewed. For more information contact a licensed chimney sweep or contractor.

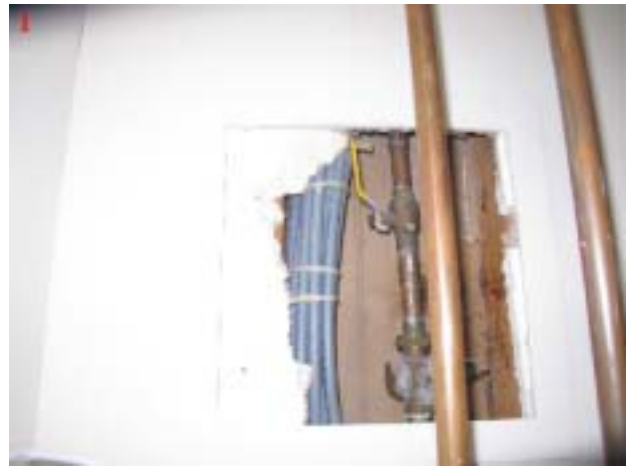
Main Water Shut Off - Utility Room

Valves are not operated as part of a home inspection.
Shut off is behind a hatch cover above the water heater.
